# **SewerLine Check Professionals, LLC**

## **Sewer Line Inspection Report**

1728 S. Centinela Ave. Los Angeles, CA 90025

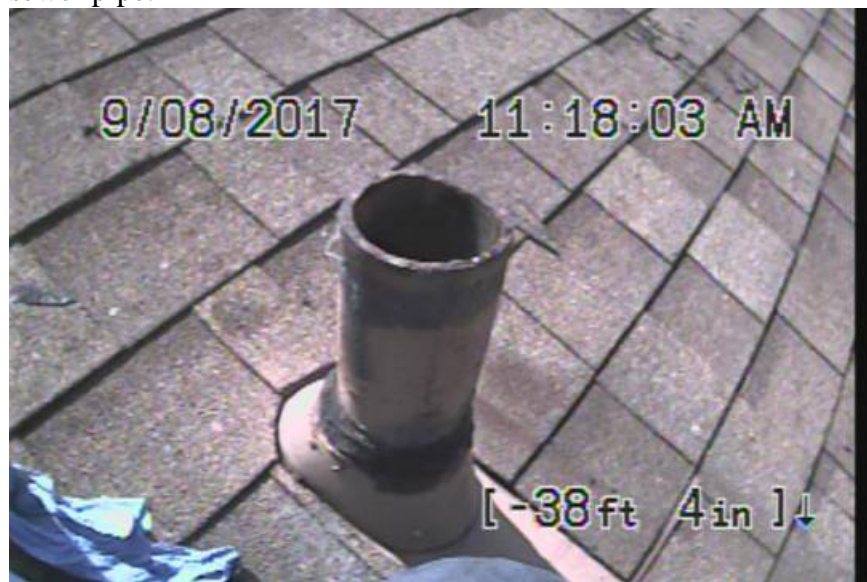
An exposed or accessible main sewer line cleanout was not found on the property. A main sewer line cleanout is an area outside the structure that has a removable cap allowing direct access into the main sewer line system. The main sewer line for this property was accessed today by dropping the camera down a drain vent that runs vertically up from the drain system under the structure and penetrates the roof. The camera was then pushed through a portion of the building drain system to get outside the structure into the main sewer pipe.

An exposed and accessible main sewer line cleanout is the standard maintenance access for any main sewer line system and all systems should have one. It is recommended that one be installed on the pipe as it exits the structure. The location has been indicated by a pink marker flag in the front planter area near the left side. The pipe is about 20 inches deep.

It is recommended that a standard main sewer line cleanout maintenance access be installed at the front of the house where indicated.

A new main sewer line cleanout is usually 6 to 8 hundred dollars.

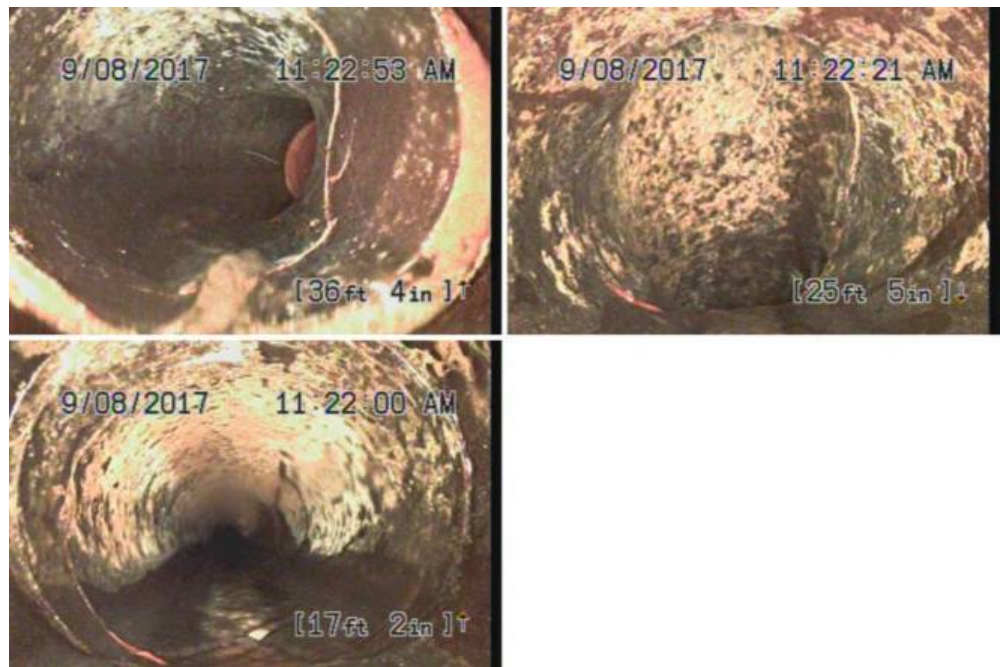
Needs Attention: There are a few light stress cracks in the clay piping but nothing that would call for repair at this point. Stress cracking is evidence of stress on the pipe but is not uncommon. One would be smart to monitor these cracks for potential future repairs but nothing is effecting the function of the system at this time.

It is our recommendation that all main sewer lines should be examined after any significant seismic activity and that main sewer lines should be examined annually to monitor for changing conditions in the system as changing conditions could potentially dictate future repairs.

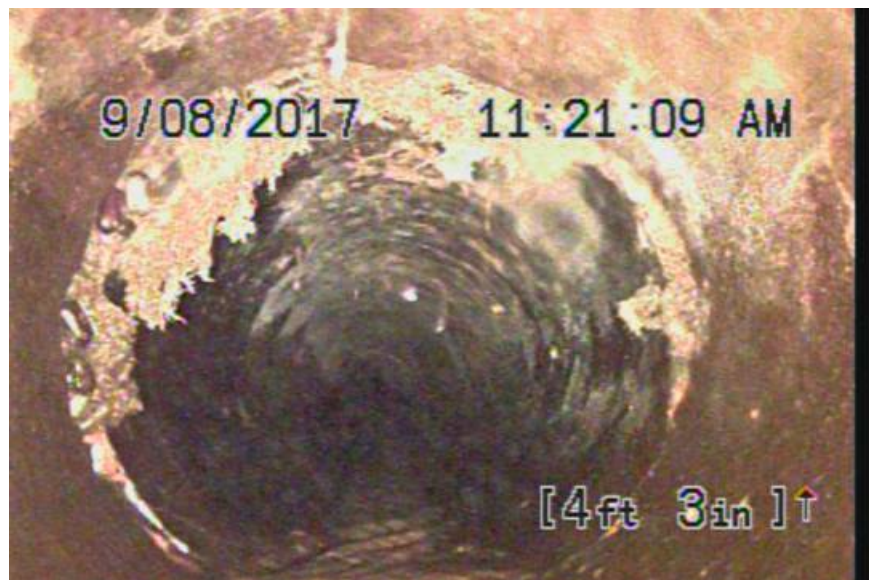
In the vitrified clay main sewer pipe, there are root intrusions at the joint areas. Root intrusions at the joint areas of a vitrified clay sewer pipe are common and can normally be maintained with regular sewer line cleanings. However, if these root intrusions are left un-maintained for extended periods, they can create blockages in the system and potentially damage the pipe itself.

It is our recommendation to have regular sewer line cleanings approximately every 8 to 12 months to maintain the root intrusions in the vitrified clay pipe. This service can help to minimize potential future blockages in the system as well as damage to the pipe.
