# **SewerLine Check Professionals, LLC**

## **Sewer Line Inspection Report**

3261 Coolidge Ave. Mar Vista, CA 90066

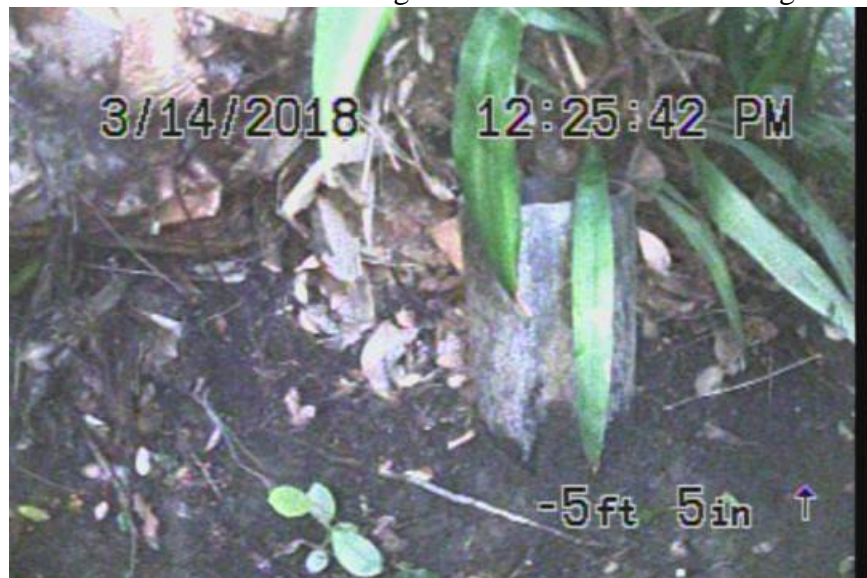
Today's examination was performed from the four inch main sewer line cleanout located at the front right of the house behind the vegetation.

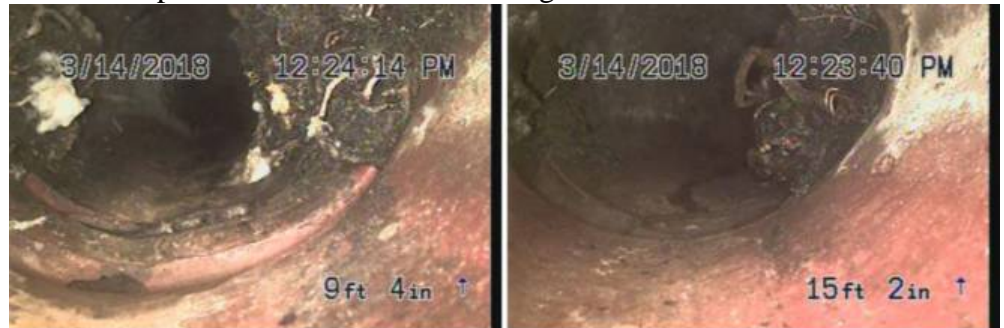
**Needs Attention:** In the vitrified clay main sewer pipe, there are root intrusions at the joint areas. Root intrusions at the joint areas of a vitrified

clay sewer pipe are common and can normally be maintained with regular sewer line cleanings. However, if these root intrusions are left un-maintained for extended periods, they can create blockages in the system and potentially damage the pipe itself. Also seen at a few of these joints are cracks or minor breaks around the joints. These are significant enough to suggest repair and is what should probably be done. That being said, with maintenance the line could be kept functional for the time being.

Repair would be replacing the first 15 feet of pipe. This is the area of the heavy vegetation and trees so that may complicate the repair some but there are methods that should be able to get it done with minimal intrusiveness, such as pipe bursting, which is a method that does not require trenching, only excavation at either end of the run.

It is suggested that it would be beneficial but not urgent to replace the first 15 feet of the line as described above.

It is our recommendation to have regular sewer line cleanings approximately every 8 to 12 months to maintain the root intrusions in the vitrified clay pipe. This service can help to minimize potential future blockages in the system as well as damage to the pipe.
