# WOOD DESTROYING PESTS AND ORGANISMS INSPECTION REPORT

Building No. 20023	Street Hinsdale Ave	City Torrance	ZIP 90503	Date of Inspection 08/13/2019	Number of Pages 5
-----------------------	------------------------	------------------	--------------	----------------------------------	----------------------

Report # : 5747

Single-family, one-story, frame/stucco (part wood sidings), single family residence, attached garage, composition roof, occupied/furnished

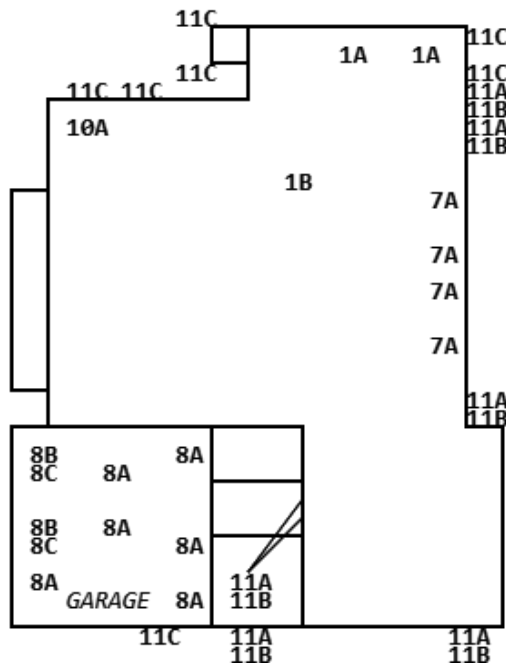
### Diagram Not To Scale

**FINDING:** Evidence of drywood termite infestation was noted at the time of inspection at the substructure area wood member(s) as indicated on the diagram.

**FINDING:** Surface fungus/dryrot condition visible at time of inspection at the sub floors, joist of the substructure area as indicated on the diagram.

**FINDING:** Evidence of drywood termite infestation was noted at the time of inspection at the attic area wood member(s) as indicated on the diagram.

**FINDING:** Evidence of drywood termite infestation was noted at the time of inspection at the garage area wood member(s) as indicated on the diagram.

**FINDING:** Evidence of drywood termite infestation was noted at the time of inspection at the framings of the garage area wood member(s) as indicated on the diagram.

**FINDING:** Evidence of drywood termite damaged wood member(s) noted at the time of inspection at the framings of the garage area as indicated on the diagram.

**FINDING:** Evidence of drywood termite infestation was noted at the time of inspection at the bedroom window of the interior area wood member(s) as indicated on the diagram.

**FINDING:** Evidence of drywood termite infestation was noted at the time of inspection at the fascia boards, sidings, rafter tail of the exterior area wood member(s) as indicated on the diagram.

**FINDING:** Evidence of drywood termite damaged wood member(s) noted at the time of inspection at the fascia boards, sidings, rafter tail of the exterior area as indicated on the diagram.

**FINDING:** Evidence of wood destroying fungus/dryrot damaged wood member(s) noted at the time of inspection at the trim, sheathings, rafter tail, water heater room door jambs of the exterior area wood member(s) as indicated on the diagram.

**RECOMMENDATION:** Fumigation. Vacate the premises and seal the structure for fumigation with Vikane Gas. Remove or cover accessible evidence (pellets) where visible and accessible. Fumigation awareness notice must be signed prior to fumigation. Two year warranty.

**RECOMMENDATION:** Scrape and chemically treat fungus condition. Proposed Pesticide(s): Tim-Bor, Tetrahydrate 98%

**RECOMMENDATION:** Repair or replace the drywood termite damaged wood member(s) noted in the above.

**RECOMMENDATION:** Repair or replace the fungus/dryrot damaged wood member(s) noted in the above.
