# WOOD DESTROYING PESTS AND ORGANISMS INSPECTION REPORT

| Building No.<br>4811 | Street<br>Frieda Dr. | City<br>Los Angeles | Zip<br>90063 | Date of Inspection<br>11/06/23 | Number of Pages<br>9 |
| General Description:<br>One Family, One Story, Frame/Stucco & Partial Wood Siding(s), Residence<br>(Furnished & Occupied), Attached Garage, Composition Shingle Roof | | | | Inspection Tag Posted | |

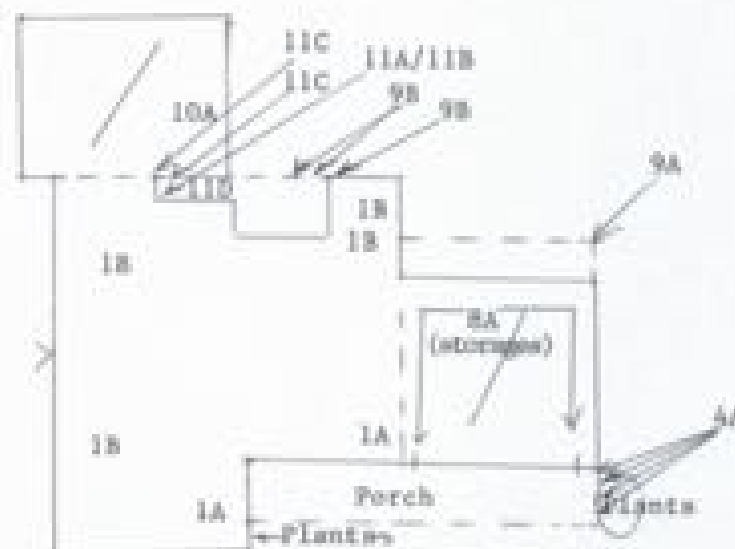
FINDING 1A : Drywood termites noted in sub area, 1A on diagram. (Section I)

FINDING 1B : Cellulose debris noted in sub area, 1B on diagram. (Section II)

FINDING 4A : Fungus damages noted on lattices, 4A on diagram. (Section I)

**FINDING 9A :** Drywood termite damages noted on rafter tail, 9A on diagram. (Section I)

**FINDING 9B :** Fungus damages noted on fascia boards and sheathing, 9B on diagram. (Section I)

**FINDING 10A :** Drywood termites noted on beam, 10A on diagram. (Section I)

**FINDING 11A :** Drywood termites noted on rafter tail, 11A on diagram. (Section I)

**FINDING 11B :** Drywood termite damages noted on rafter tail, 11B on diagram. (Section I)

**FINDING 11C :** Fungus damages noted on door and rafter tail, 11C on diagram. (Section I)

**FINDING 11D :** Water stain(s) noted on eave, 11D on diagram. (Section II)

RECOMMENDATION 1A : Seal the entire structure, and fumigate with a state-approved fumigant (Vikane; sulfuryl fluoride with chloropicrin as warning agent) for the eradication of drywood termites (kaloterms). This process is guaranteed to eliminate all present drywood termites (kaloterms). Remove or cover the evidence of termites, where visible and/or accessible. Top Termite Co., Inc. guarantees fumigation for drywood termites (kaloterms) for two years.

RECOMMENDATION 1B : Remove loose cellulose debris from sub area.

RECOMMENDATION 4A : Remove, and replace or reinforce damaged wood members with new materials (primer only). Damaged wood members which are not structurally weakened will be repaired with strong wood fillers (primer only).

**RECOMMENDATION 9A :** Remove, and replace or reinforce damaged wood members with new materials (primer only). Damaged wood members which are not structurally weakened will be repaired with strong wood fillers (primer only).

**RECOMMENDATION 9B :** Remove, and replace or reinforce damaged wood members with new materials (primer only). Damaged wood members which are not structurally weakened will be repaired with strong wood fillers (primer only).

**RECOMMENDATION 10A :** Seal the entire structure, and fumigate with a state-approved fumigant (Vikane; sulfuryl fluoride with chloropicrin as warning agent) for the eradication of drywood termites (kalotermites). This process is guaranteed to eliminate all present drywood termites (kalotermites). Remove or cover the evidence of termites, where visible and/or accessible. Top Termite Co., Inc. guarantees fumigation for drywood termites (kalotermites) for two years.

**RECOMMENDATION 11A :** Seal the entire structure, and fumigate with a state-approved fumigant (Vikane; sulfuryl fluoride with chloropicrin as warning agent) for the eradication of drywood termites (kaloterms). This process is guaranteed to eliminate all present drywood termites (kaloterms). Remove or cover the evidence of termites, where visible and/or accessible. Top Termite Co., Inc. guarantees fumigation for drywood termites (kaloterms) for two years.

**RECOMMENDATION 11B :** Damaged wood member will be repaired with a strong wood filler (primer only).

**RECOMMENDATION 11C :** Remove, and replace or reinforce damaged wood members with new materials (primer only).

**RECOMMENDATION 11D :** Employ an appropriate tradesman to correct cause of water stain(s), and make necessary repairs.
