Date: February 29, 2024

SEWER LINE INSPECTION REPORT

Client Name: Casa For You LLC

Property Address: 2902 Reservoir St, Los Angeles, CA 90026, Silver Lake

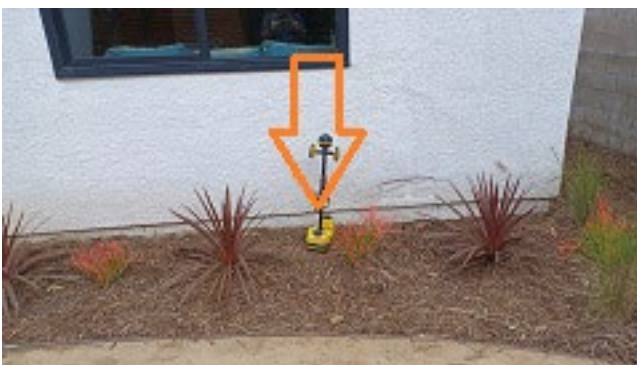
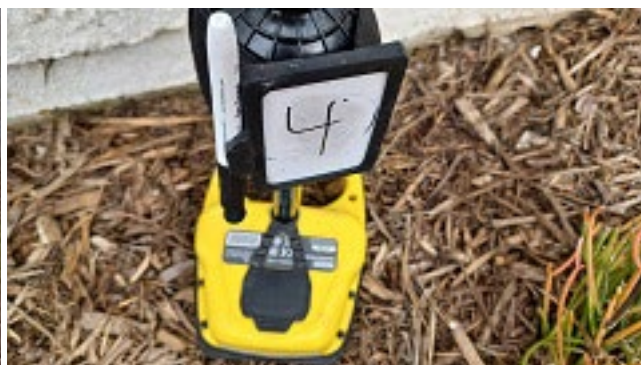
The sewer line leaving the house about 4 feet deep

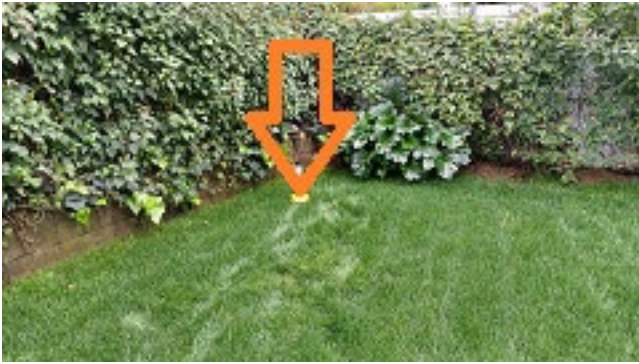
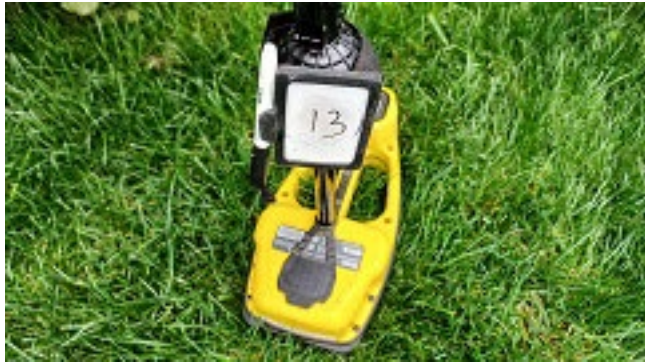
The connection to the city sewer about 13 feet deep

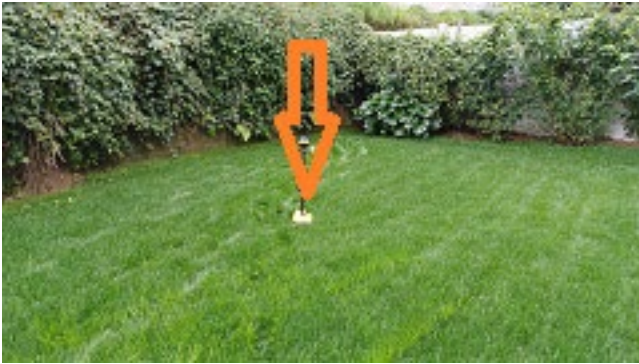
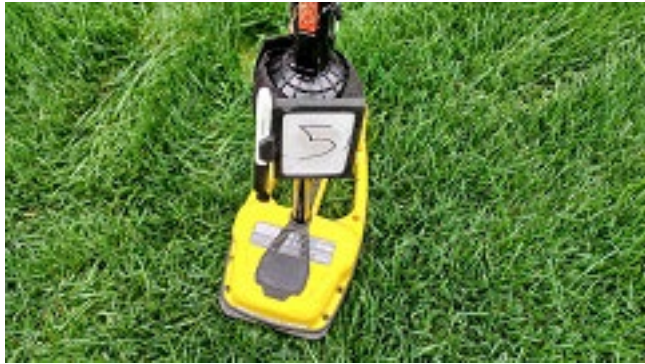
The sewer line traveling across the back yard about 5 feet deep

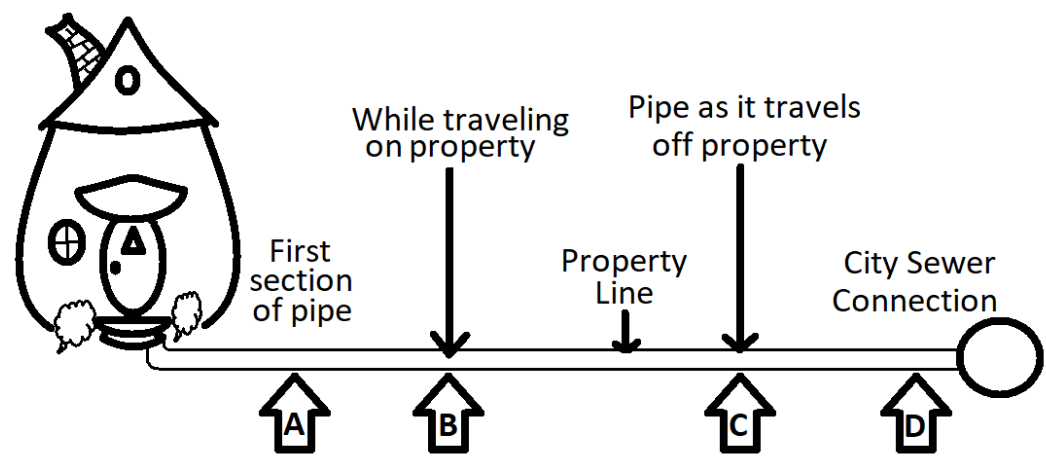
Pipe materials:

- A: Plastic
- B: clay with sections of plastic
- C: clay
- D: clay

The plastic portion of the system appears to be functioning. Plastic is an excellent material for sewer line applications. It does not rust it is flexible. The joints of the pipe do not allow for root intrusion when it is properly installed. This provides a trouble free use from plastic for a very long service time. An investigation into plastic sewer pipe performance done for San Francisco city estimated the expected useful life of plastic sewer pipe to be 200 years.

The clay portion of this sewer line is functioning , but has some defects in the condition of the pipe typical to clay sewer lines. These include some cracking as well as some misalignment of the joints in the pipe. It is very rare to find a clay line which has no minor defects and this pipe is in about average condition, compared to most properties. While this line is not perfect it is fully functional at this time.

Typically clay sewer lines should receive cleanings once every 24-36 months. The clay in this sewer line has little root intrusion at this time. This may be due to being recently cleaned. For this reason I am recommending that the line be looked at in a 2 years to help determine how rapidly roots are able to get into the line.
