WOOD DESTROYING PESTS AND ORGANISMS INSPECTION REPORT

Building No. 5014	Street COLLEGE VIEW AVE.	City EAGLE ROCK	ZIP 90041	Date of Inspection 03/14/2024	Number of Pages 8
----------------------	-----------------------------	--------------------	--------------	----------------------------------	----------------------

Hi-Tech Termite Control 5555 Magnatron Blvd Ste L San Diego CA 92111 (800) 291-3019 Office@hi-techtermitecontrol.com	Report # : 112408 Registration # : PR2967 Escrow # : <input type="checkbox"/> CORRECTED REPORT
-----------------------------------------------------------------------------------	-----------------------------------------------------------------------------------------------------------------------------------------	---------------------------------------------------------------------------------------------------------

GENERAL DESCRIPTION: 2 STORY STUCCO AND WOOD-SIDED SINGLE FAMILY RESIDENCE FURNISHED AND OCCUPIED WITH A COMPOSITION ROOF DETACHED GARAGE UNIMPROVED UNDER AREA.	Inspection Tag Posted: Garage
	Other Tags Posted: HOME SAVING 2009

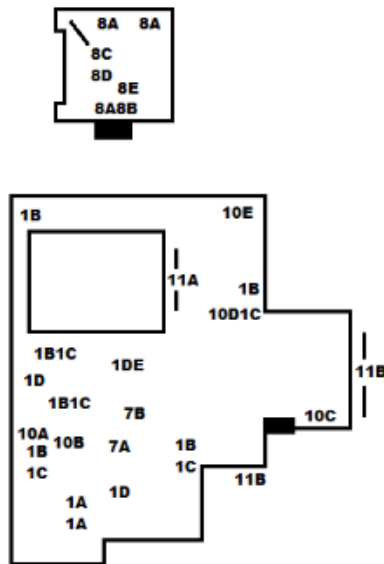
Diagram Not To Scale

FINDING-EVIDENCE OF AN ACCESSIBLE DRYWOOD TERMITE INFESTATION NOTED AT SUBAREA FRAMING AS INDICATED BY 1A ON THE DIAGRAM.

FINDING-MOISTURE STAIN NOTED AT NUMEROUS LOCATION OF SUBFLOOR FRAMING AS INDICATED BY 1B ON THE DIAGRAM.

FINDING-SURFACE FUNGUS NOTED AT NUMEROUS LOCATIONS OF SUBFLOOR FRAMING AS INDICATED BY 1C ON THE DIAGRAM.

FINDING-CELLULOSE DEBRIS NOTED AT SCATTERED SITES OF THE SUBAREA AS INDICATED BY 1D ON THE DIAGRAM.

FINDING-EVIDENCE OF AN ACCESSIBLE DRYWOOD TERMITE INFESTATION NOTED AT ATTIC FRAMING AS INDICATED BY 7A ON THE DIAGRAM.

FINDING-INACCESSIBLE AREAS NOTED AT PORTIONS OF THE ATTIC DUE TO CONSTRUCTION STYLE AS INDICATED BY 7B ON THE DIAGRAM.

FINDING-EVIDENCE OF SUBTERRANEAN TERMITES NOTED AT VARIOUS LOCATIONS OF GARAGE FRAMING AS INDICATED BY 8A ON THE DIAGRAM.

FINDING-SUBTERRANEAN TERMITE DAMAGE NOTED AT GARAGE WALL FRAMING AS INDICATED BY 8B ON THE DIAGRAM.

FINDING-EVIDENCE OF AN ACCESSIBLE DRYWOOD TERMITE INFESTATION NOTED AT VARIOUS LOCATIONS OF GARAGE FRAMING AS INDICATED BY 8C ON THE DIAGRAM.

FINDING-DRYWOOD TERMITE DAMAGE NOTED AT VARIOUS LOCATIONS OF GARAGE FRAMING AS INDICATED BY 8D ON THE DIAGRAM.

FINDING-MOISTURE STAIN NOTED AT GARAGE ROOF FRAMING AS INDICATED BY 8E ON THE DIAGRAM.

FINDING-PLUMBING LEAK NOTED UNDER THE KITCHEN SINK AS INDICATED BY 10A ON THE DIAGRAM.

FINDING-MOISTURE DAMAGE NOTED UNDER THE KITCHEN SINK AS INDICATED BY 10B ON THE DIAGRAM.

FINDING-PLASTER DAMAGE NOTED AT WALL NEXT TO THE FIREPLACE AS INDICATED BY 10C ON THE DIAGRAM.

FINDING-FUNGUS AND DRY ROT NOTED AT FLOORING NEXT TO THE SIDE DOOR AS INDICATED BY 10D ON THE DIAGRAM.

FINDING-DRYWOOD TERMITE DAMAGE NOTED AT BEDROOM & CLOSET FRAMING AS INDICATED BY 10E ON THE DIAGRAM.

FINDING-FUNGUS AND DRY ROT NOTED AT UPPER LEVEL WINDOW SILL AS INDICATED BY 11A ON THE DIAGRAM.

FINDING-FUNGUS AND DRY ROT NOTED AT WALL TRIM BOARDS AS INDICATED BY 11B ON THE DIAGRAM.

RECOMMENDATION-PRIMARY: VACATE PREMISES AND SEAL STRUCTURE. FUMIGATE WITH A LETHAL GAS (SULFURYL FLUORIDE). REMOVE THE SEALS AND AIR OUT BUILDING. MAKE READY FOR OCCUPANCY. COVER AND/OR REMOVE EVIDENCE. AREA MUST BE VACATED AT TIME OF APPLICATION.

RECOMMENDATION: OWNER OR OWNER'S LICENSED CONTRACTOR TO CORRECT MOISTURE CONDITION AND/OR PRIME AND PAINT AREA TO CORRECT. IF DAMAGE EXTENDS INTO INACCESSIBLE AREA(S) HI TECH TERMITE CONTROL WILL SUBMIT A SUPPLEMENTAL REPORT AND/OR BID IF NECESSARY. HI TECH TERMITE CONTROL IS NOT RESPONSIBLE FOR THE WORK OF OTHERS.

TREAT SURFACE FUNGUS WOOD WITH STATE REGISTERED FUNGICIDE TIMBOR (DISODIUM OCTOBORATE TETRAHYDRATE 98%), OR BORA-CARE (DISODIUM OCTOBORATE TETRAHYDRATE 40%) FOR THE CONTROL OF SURFACE FUNGUS. THIS IS A SECONDARY RECOMMENDATION AND DOES NOT GUARANTEE THE REMOVAL OF SURFACE FUNGUS. THIS IS NOT AN ADEQUATE TREATMENT FOR ESCROW CLEARANCE.

RECOMMENDATION: OWNER TO REMOVE CELLULOSE DEBRIS FROM PROPERTY.

OWNER TO MAKE AREA ACCESSIBLE IF FURTHER INSPECTION IS DESIRED. AREA WILL BE COVERED UNDER OUR WHOLE HOUSE WARRANTY. IF TREATMENT IS NEEDED IN AREA, THEN IT WILL BE THE OWNER'S RESPONSIBILITY TO MAKE THE AREA ACCESSIBLE FOR SUCH TREATMENT.

AT TIME OF INSPECTION, SUBTERRANEAN TERMITES WERE FOUND ATTACKING THE STRUCTURE. PER CHEMICAL LABEL, A FULL PERIMETER TREATMENT IS RECOMMENDED TO CONTROL/ELIMINATE SUBTERRANEAN TERMITE COLONIES USING A STATE REGISTERED CHEMICAL TERMIDOR (Fipronil 9.1%) OR (fipronil: 5-amino-1-[2,6-dichloro-4-(trifluoromethyl)phenyl]-4-[(1, R, S)-(trifluoromethyl)sulfinyl]-1H-pyrazole-3-carbonitrile) 8.73%). SOIL TREATMENT AROUND PERIMETER WILL BE TREATED AS SUCH: TRENCH AND TREAT PERIMETER SOIL AROUND THE STRUCTURE OR ROD INJECT INTO THE SOIL. CONCRETE, BRICK, OR OTHER SOLID FINISHED MATERIALS WILL BE TREATED AS SUCH: DRILL THROUGH THE MATERIAL AND PRESSURE INJECT THE SOIL BENEATH FOR THE CONTROL OF SUBTERRANEAN TERMITES. WHILE EXTREME CAUTION AND CARE IS EXERCISED, HI-TECH TERMITE CONTROL WILL NOT BE RESPONSIBLE FOR ANY POSSIBLE DAMAGE TO HIDDEN PIPES, CONDUITS, DUCTS, BRICKS, TILES, SLATE, MARBLE, OR ANY OTHER LAID MATERIAL IN THE COURSE OF WORK. HI-TECH TERMITE CONTROL WILL SEAL AND PATCH HOLES WITH CONCRETE PATCH. GFI PLUGS (stop boxes) ARE USED DURING THIS PROCESS AND WILL SHUT OFF THE DRILL IF IT MAKES CONTACT WITH ANY METAL. DECK BOARDS ARE TO BE REMOVE BY OWNER PRIOR TO TREATMENT. IF OWNER WOULD PREFER TO HAVE THE BOARDS DRILLED, THEN THERE WILL BE NO PATCHING ON THE DECK BOARDS. REMOVE ALL ACCESSIBLE TERMITE TUBING/EVIDENCE. IF POSSIBLE, LOCAL TREATMENT WILL ALSO BE PERFORMED BY INJECTING TERMIDOR (Fipronil 9.1%) DIRECTLY INTO THE INFESTED WOOD MEMBER(S).

AS NECESSARY, REPAIR DAMAGED WOOD. MINOR TERMITE DAMAGED WOOD WILL BE FILLED WITH BONDO. NEW WOOD WILL BE COATED WITH ONE COAT OF PRIMER PAINT. IF FURTHER DAMAGE IS FOUND IN AREAS THAT BECOME ACCESSIBLE DURING THE REPAIRS, THEN A SUPPLEMENTAL REPORT AND BID WILL BE FURNISHED TO THE OWNER. HI-TECH TERMITE CONTROL INC. DOES NOT SUB-CONTRACT THE WORK. IF THE OWNER HAS

AS NECESSARY, REPAIR DAMAGED WOOD. MINOR TERMITE DAMAGED WOOD WILL BE FILLED WITH BONDO. NEW WOOD WILL BE COATED WITH ONE COAT OF PRIMER PAINT. IF FURTHER DAMAGE IS FOUND IN AREAS THAT BECOME ACCESSIBLE DURING THE REPAIRS, THEN A SUPPLEMENTAL REPORT AND BID WILL BE FURNISHED TO THE OWNER. HI-TECH TERMITE CONTROL INC. DOES NOT SUB-CONTRACT THE WORK. IF THE OWNER HAS REPAIRS PERFORMED BY OTHERS, THEN HI-TECH TERMITE CONTROL INC. DOES NOT GUARANTEE THE REPAIRS. ALL REPAIRS PERFORMED BY HI-TECH TERMITE CONTROL INC. COME WITH A ONE (1) YEAR GUARANTEE. IF OWNER PROVIDES PAINT, THEN HI-TECH TERMITE CONTROL INC. CAN APPLY PAINT AT NO ADDITIONAL COST. HI-TECH TERMITE CONTROL INC. IS NOT RESPONSIBLE FOR MATCHING PAINT COLORS BETWEEN NEW AND EXISTING PAINT.

RECOMMENDATION: OWNER TO CONTACT A LICENSED PLUMBER TO MAKE NECESSARY REPAIRS.
SECTION 2

OWNER TO CONTACT A LICENSED TRADES-PERSON TO MAKE NECESSARY REPAIRS. HI-TECH TERMITE CONTROL INC. IS NOT RESPONSIBLE FOR THE WORKMANSHIP OF OTHERS.

OWNER TO CONTACT A LICENSED CONTRACTOR FOR FURTHER INSPECTION AND/OR TO MAKE NECESSARY REPAIRS. HI-TECH TERMITE CONTROL IS NOT RESPONSIBLE FOR THE WORKMANSHIP OF OTHERS.
