WOOD DESTROYING PESTS AND ORGANISMS INSPECTION REPORT

Building No. 2270	Street EAST SMOKEWOOD AVENUE	City PALM SPRINGS	ZIP 92264	Date of Inspection 05/02/2024	Number of Pages 4
----------------------	---------------------------------------	----------------------	--------------	----------------------------------	----------------------

Report # : 12811

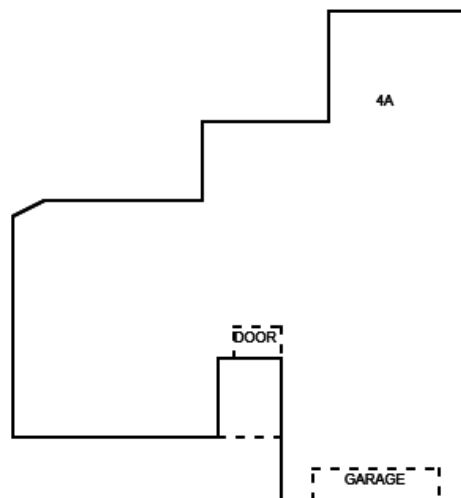
Diagram Not To Scale

FINDING - Evidence of water stain found on finished ceiling in master bedroom as noted on diagram as 4A. Dry at time of inspection.

RECOMMENDATION - call licensed contractor for further inspection
