PROPERTY INSPECTION REPORT

431 Suave Lane
Palm Springs, Ca

Prepared for: Jim D'Angelo RI (2-10-25)

Prepared by: CTS Inspections

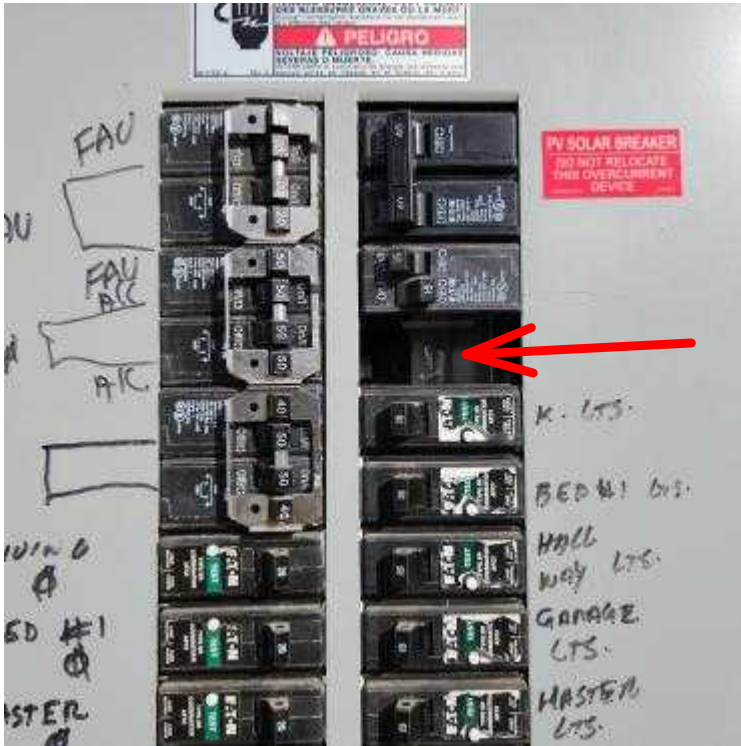
Interior cover to electrical panel missing knockout insert

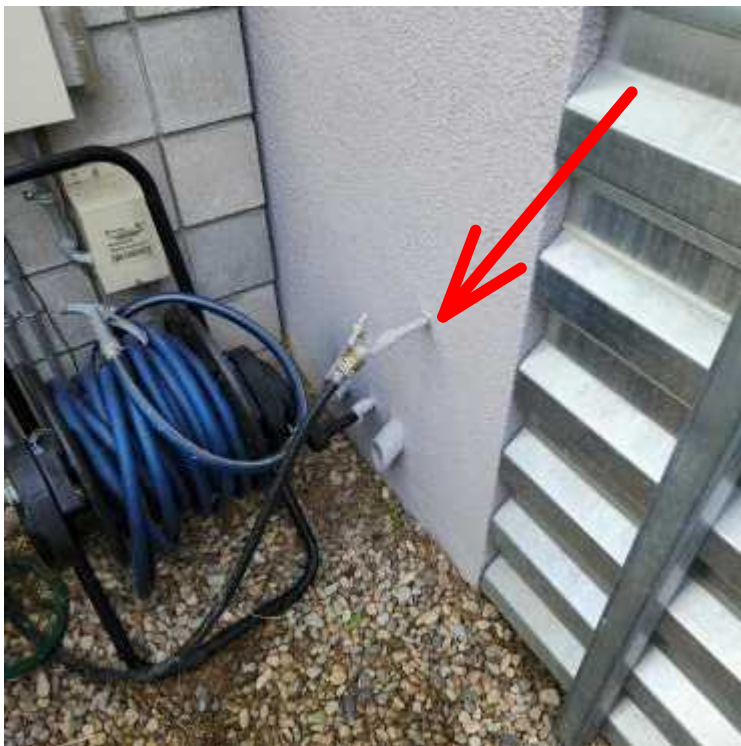
Water pipe to hose bib on west side of house loose in wall (adjacent to pool equipment)

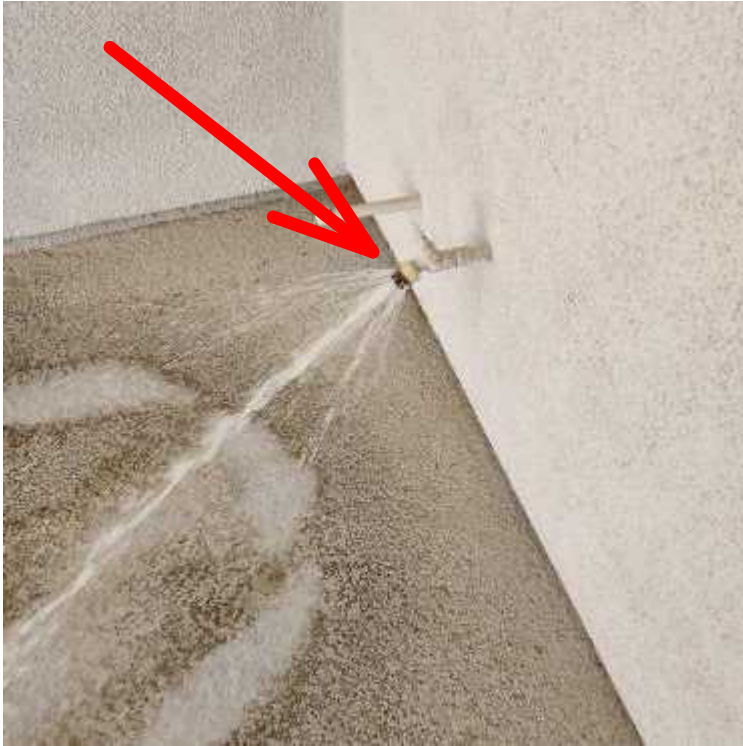
Damaged/Leaking anti-siphon valve to hose bib on third floor patio

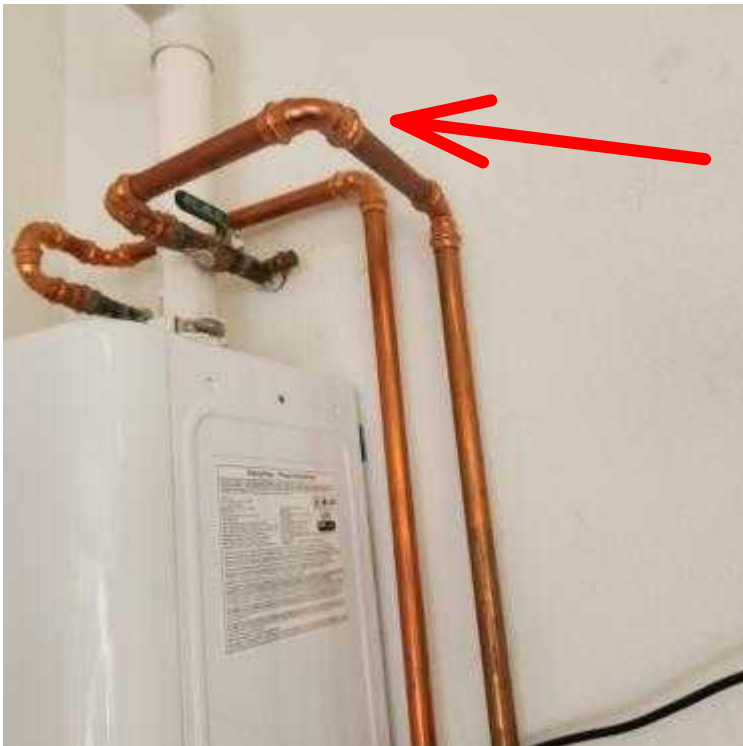
Missing thermal expansion tank on plumbing to water heater-NTBS

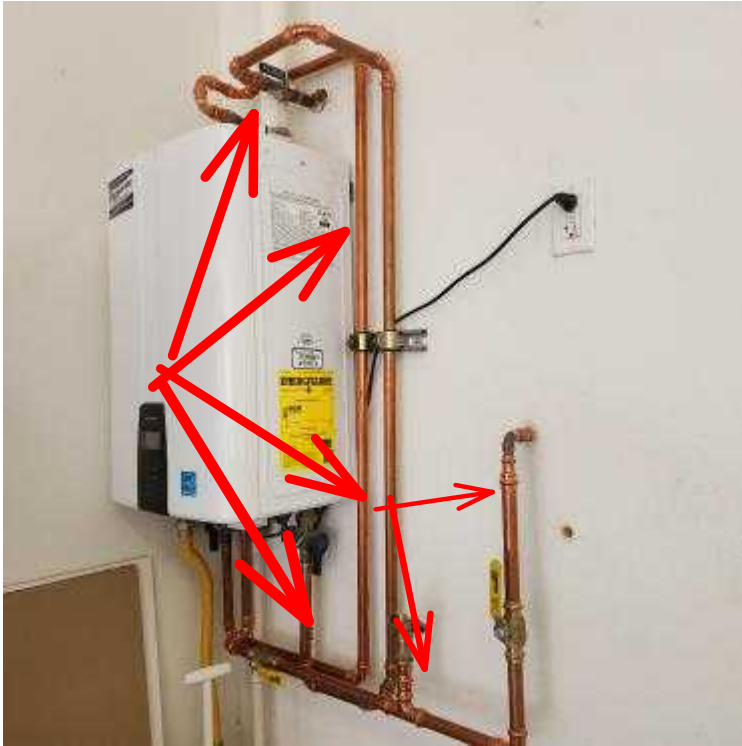
Missing insulation on supply/flow pipes to water heater-NTBS

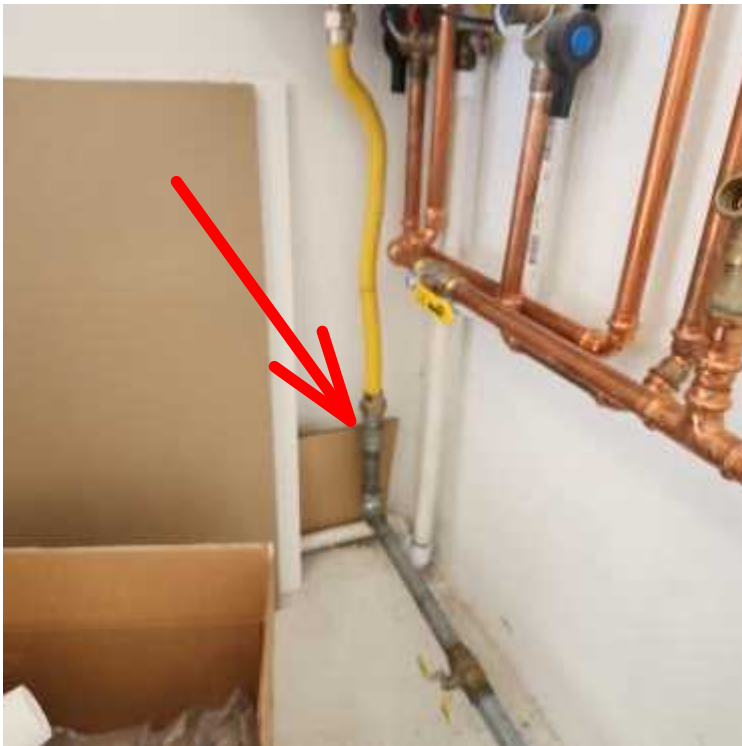
Missing sediment trap on gas supply pipe to water heater-NTBS

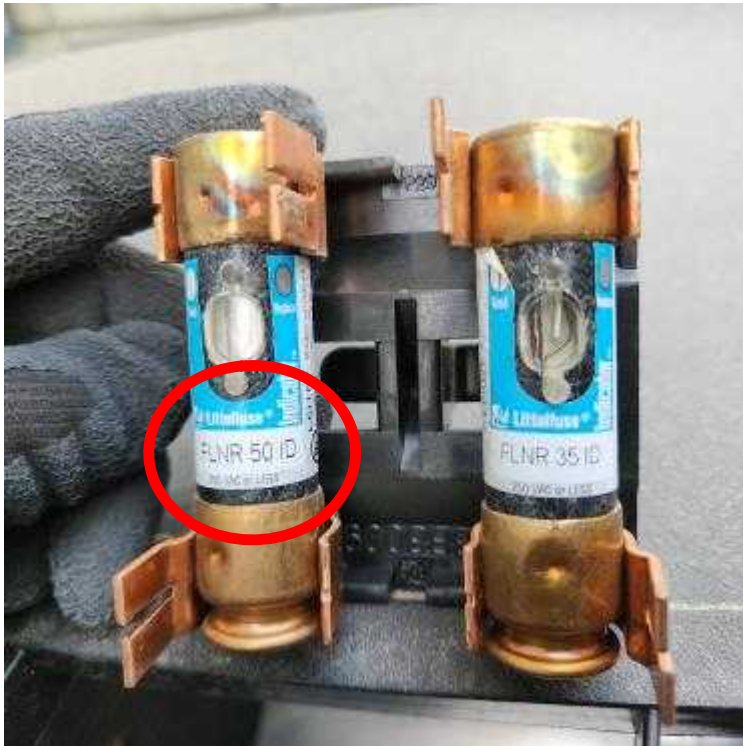
Fuse amperage for South AC Heat Pump Condenser overcurrent exceeds unit requirement (40 amp max required-One 50 amp present inside disconnect

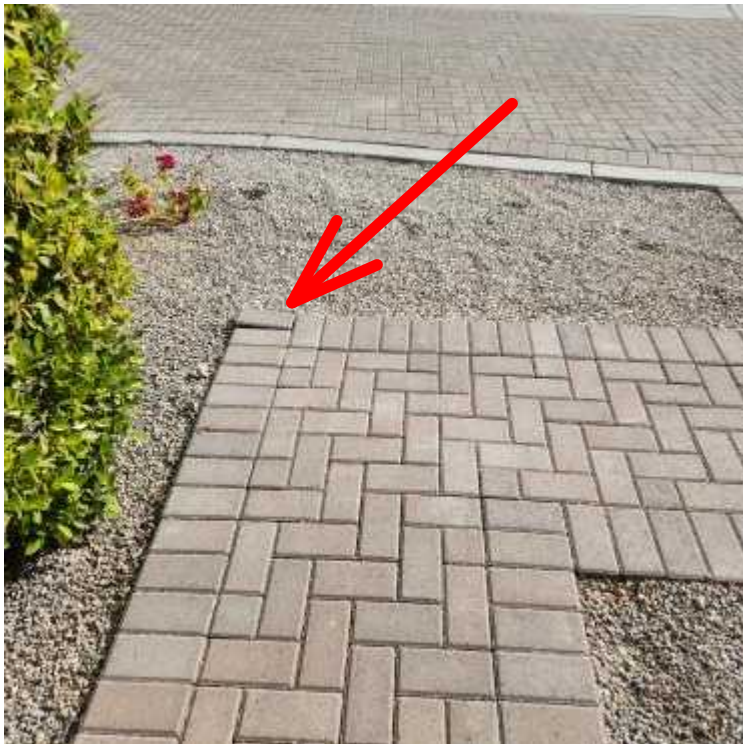
(1) loose/dislodged paver on entry walkway to house

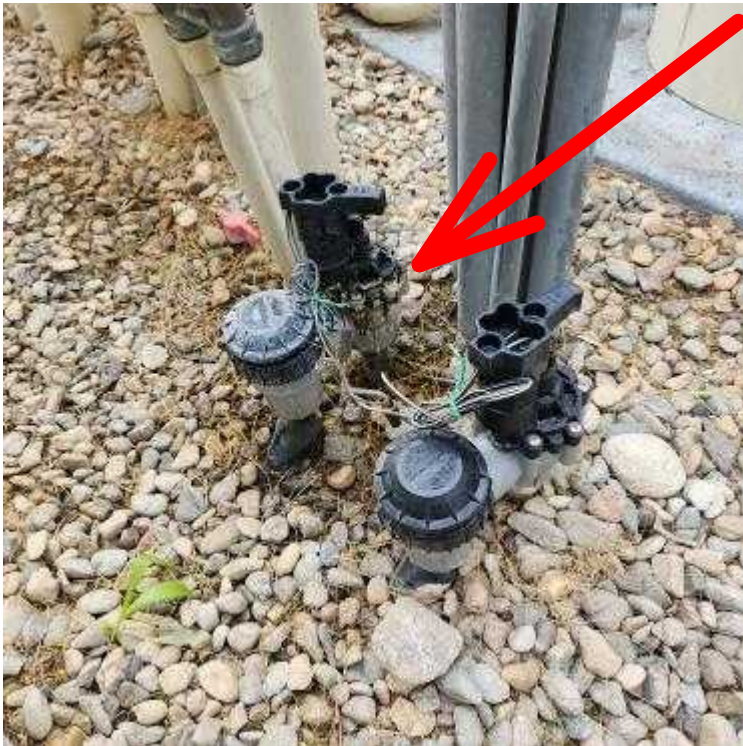
(1) Sprinkler valve on west side of house leaks continuously during operation-Standing water present after test

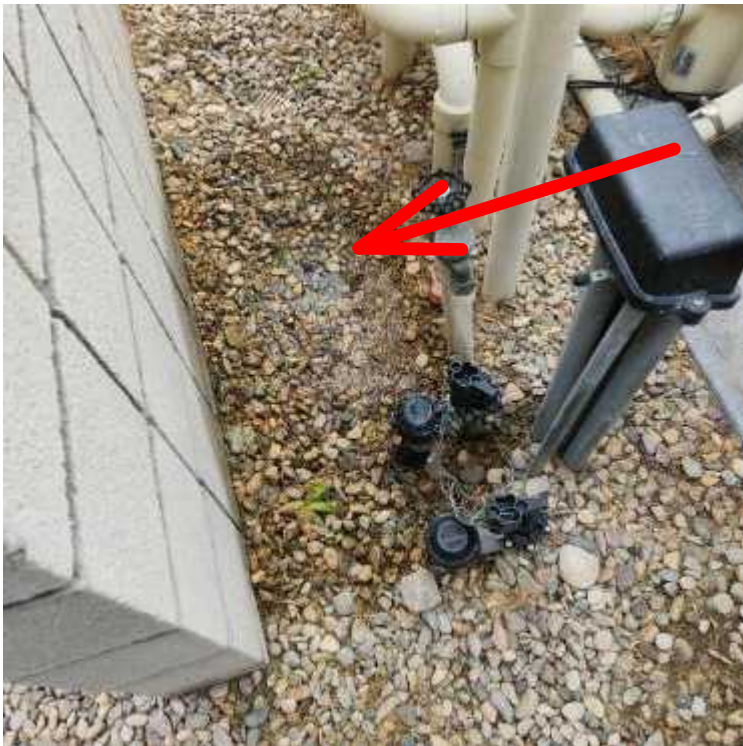
(1) Sprinkler valve on west side of house leaks continuously during operation with possible below grade leaking from pipes-Standing water present after test

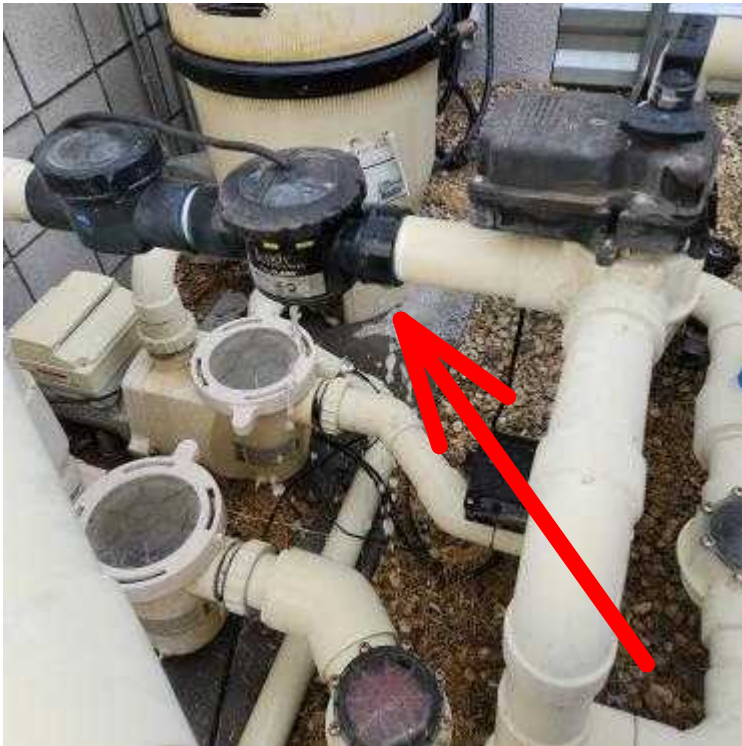
Leaking plumbing to pool equipment at connection to salt/chlorine cell when valves in spa setting

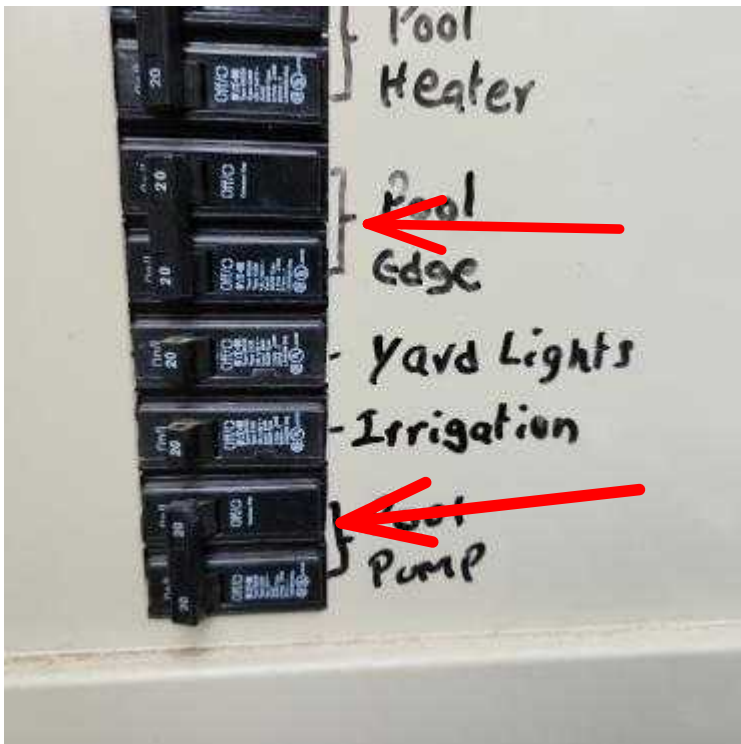
(2) Pool/Spa pumps not connected to GFCI breakers inside sub electrical panel-NTBS

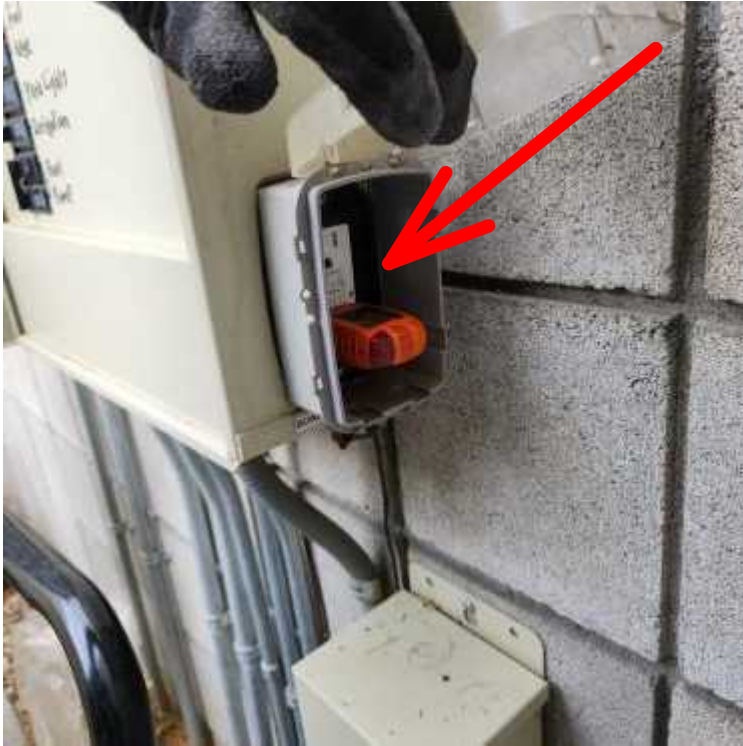
GFCI outlet to pool & spa lights inoperative/did not reset-NTBS

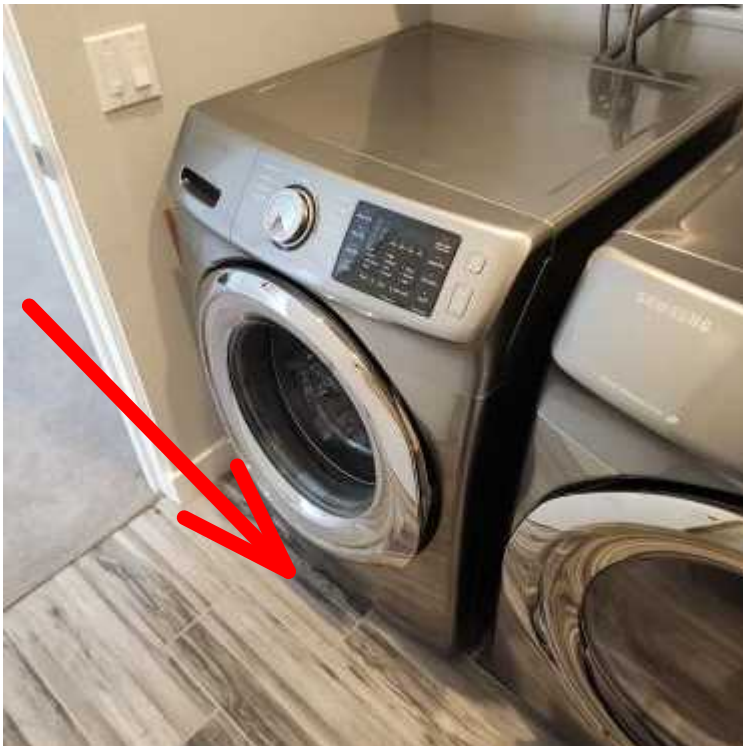
☐☒☐☐ Floors- Tile Missing catch pan with drain pipe on floor under washer in laundry room
(Remains 2-10-25)

Missing catch pan with drain pipe on floor under washer in laundry room

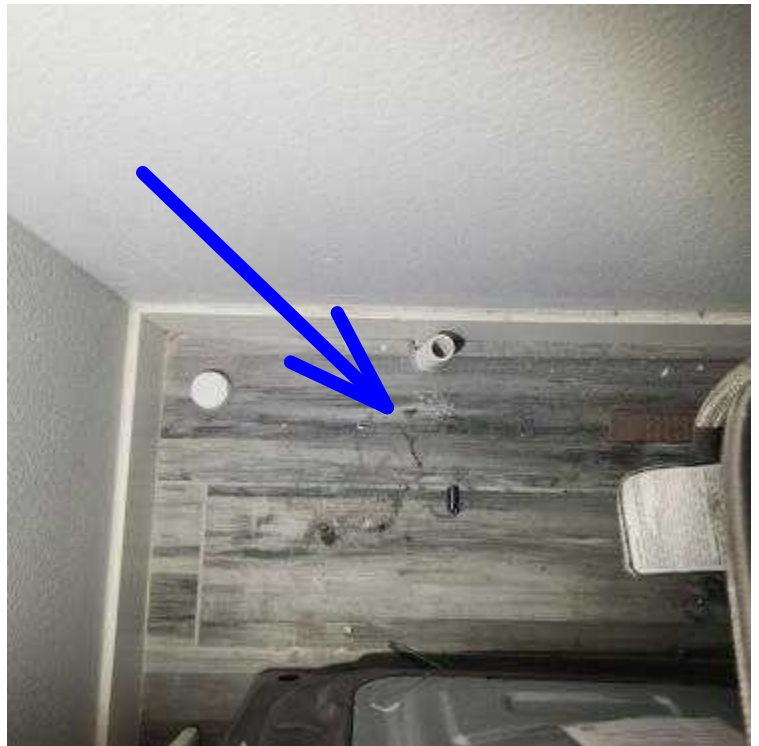
Missing catch pan with drain pipe on floor under washer in laundry room (Remains 2-10-25)

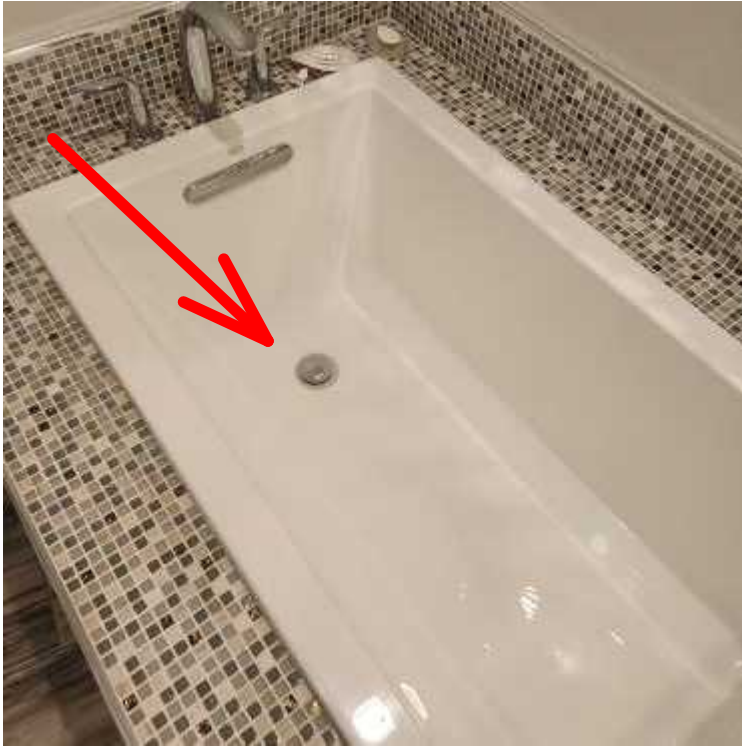
Downstairs bathroom tub drains slow

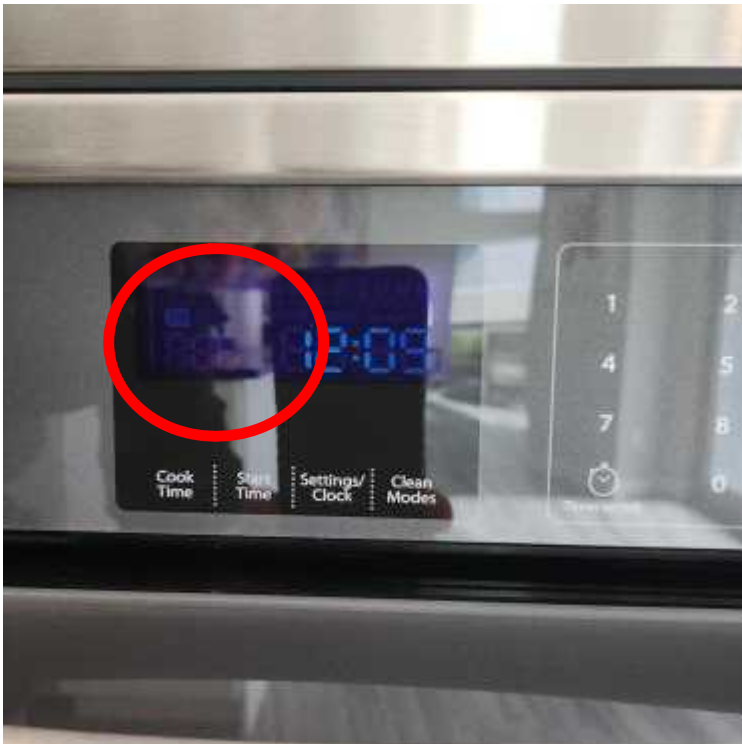
Low illumination of temperature on oven display panel

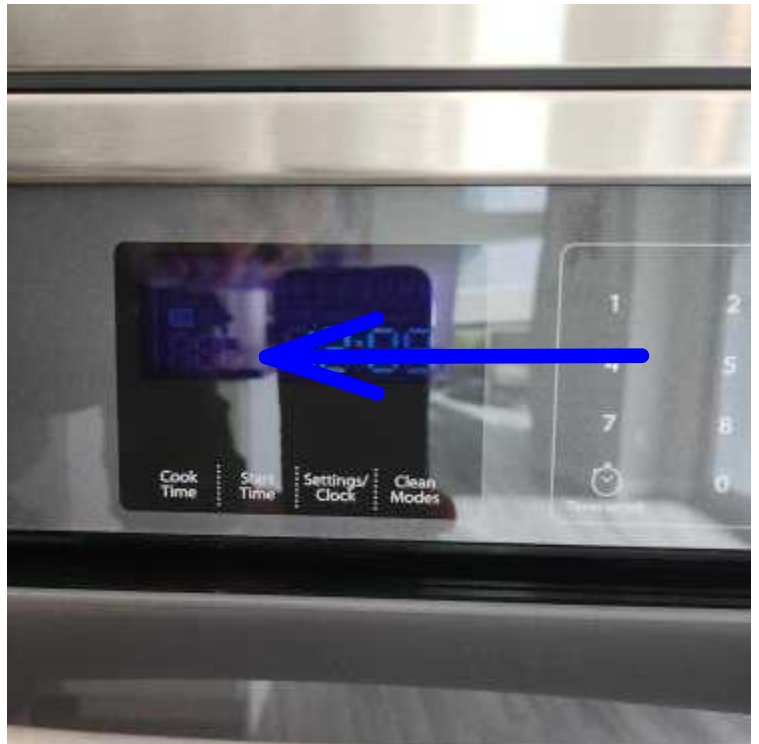
Low illumination of temperature on oven display panel deemed normal per manufacture (2-10-25)
