Real Estate Inspection Report

LARocca
INSPECTION ASSOCIATES

Newman Family Trust

11911 Lawler St, Los Angeles CA

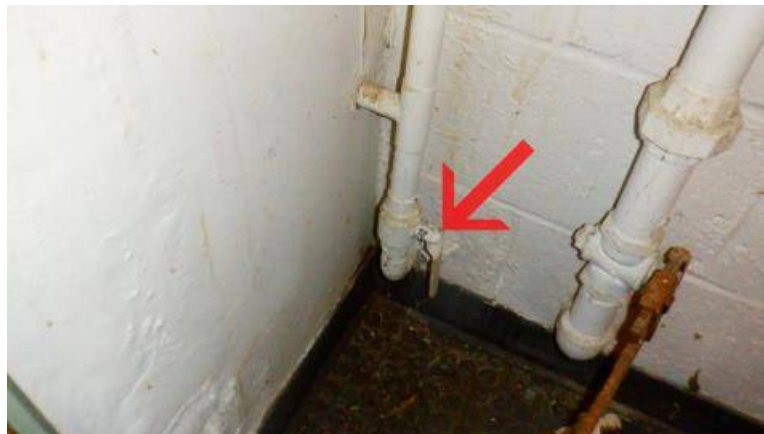
In the garage level stairway landing area.

Serviceable.

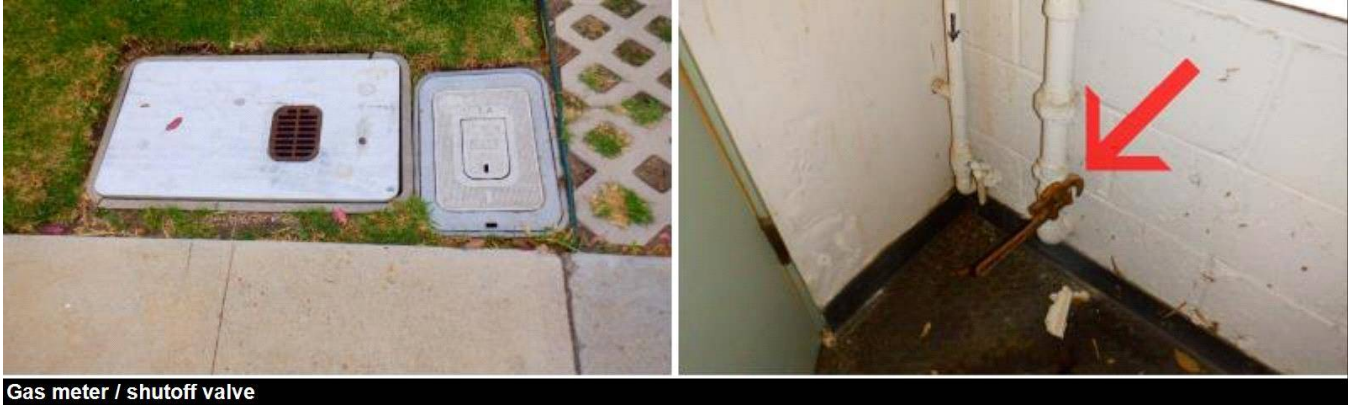
Gas meter / shutoff valve

There is no automatic seismic gas shut-off valve on the main gas line. This may need to be installed before the close of escrow.

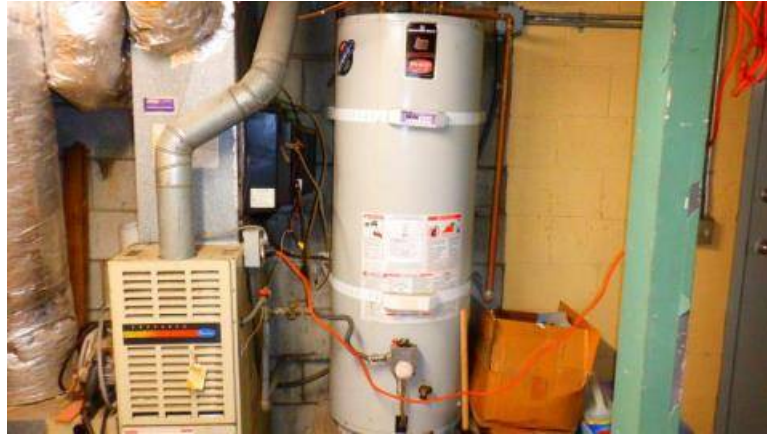
The water heater is located in the garage.

Needs Attention, there is no drain pan below the water heater, this is advised in case the water heater leaks so that the water can be carried away from the garage space/tank platform.

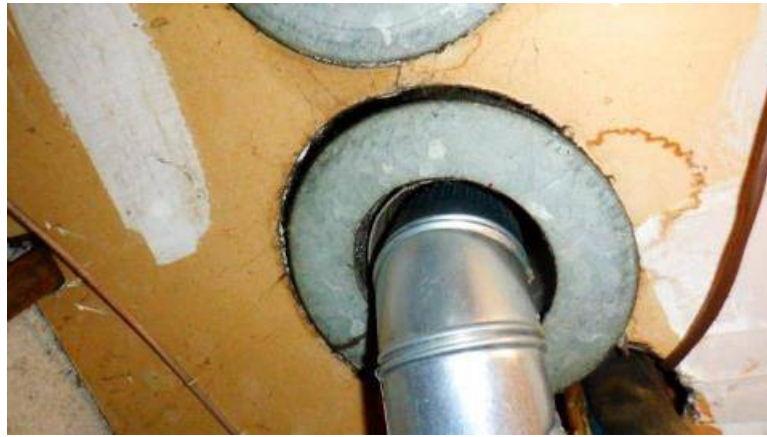
Not Acceptable, The water heater exhaust vent is not properly connected. This can allow exhaust gases to escape and is considered a health and safety hazard and should be repaired by a qualified plumber. There are gaps where the single wall pipe meets the ceiling that may allow exhaust gases to leak.

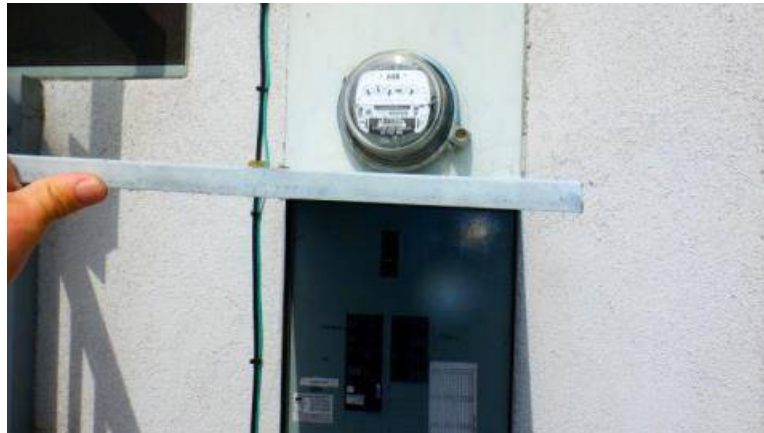
The main electrical panel is located on the right exterior side of the building.

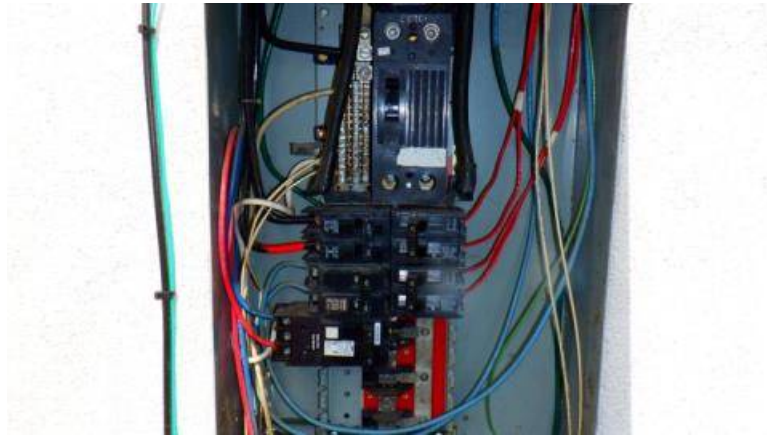
Serviceable

Note, the directory or labels for the breakers are not complete so it is not clear what each breaker serves. Ideally this would be done.

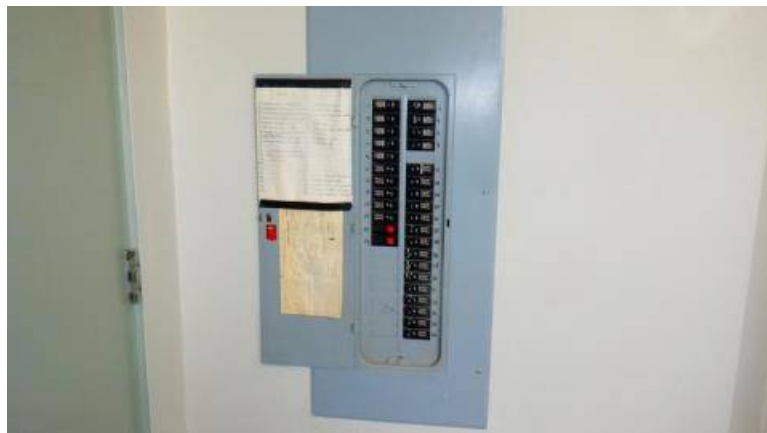
There is an electrical subpanel, in the laundry room.

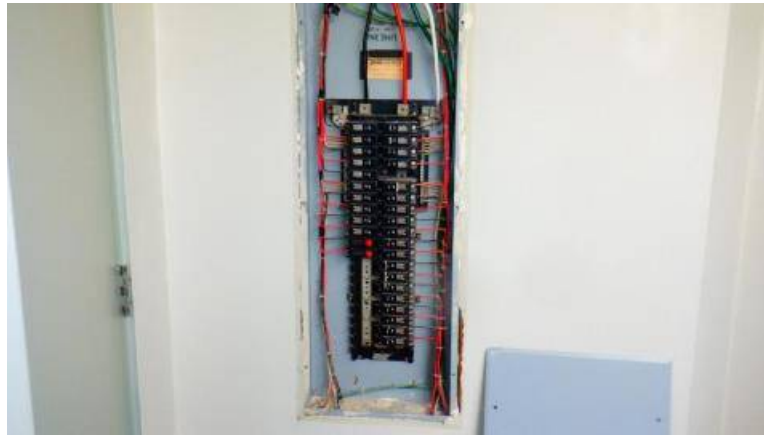
Needs Attention: The inside cover fastener is pointed at the end and may break the insulation of a wire and cause a short. It should be a dull ended fastener

Otherwise, it appears to be serviceable.

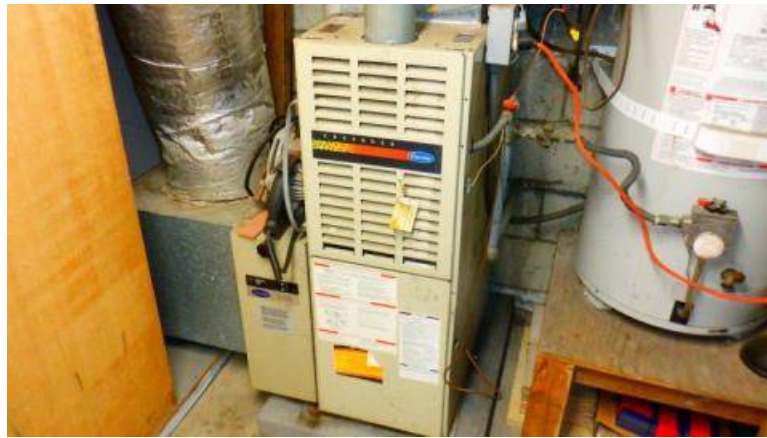
The heating unit is located in the garage.

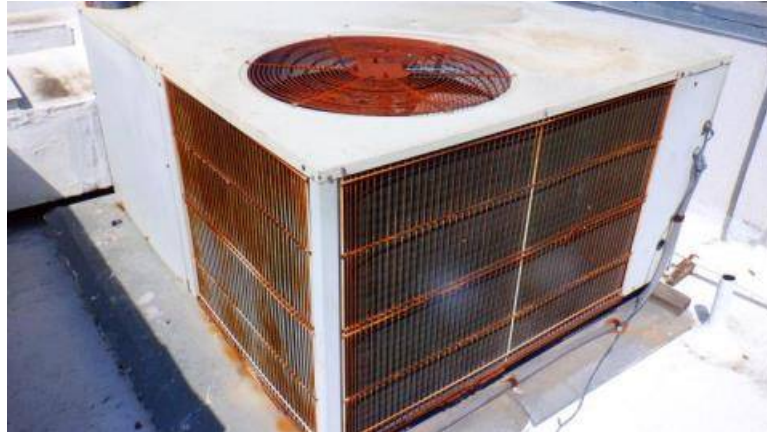
The system is located on the roof.

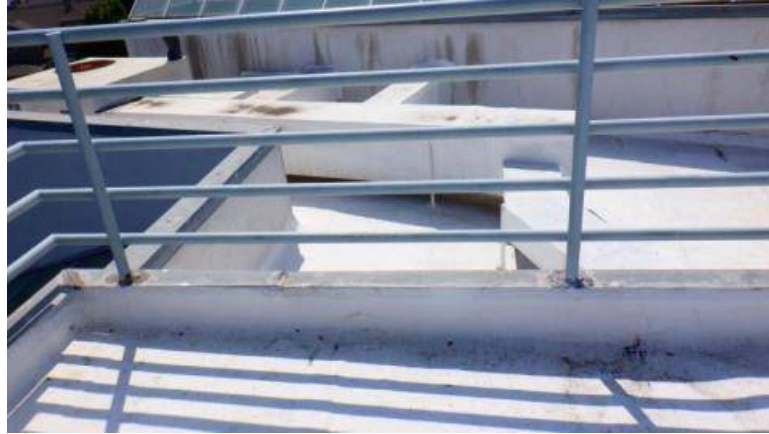
Needs Attention: The mastic is cracked in areas and is not reliable to ensure a watertight seal. Such as at the bottom of the railing posts and parapet wall capping.

There are penetrations through the roof that are going to require high maintenance and should be closely monitored.

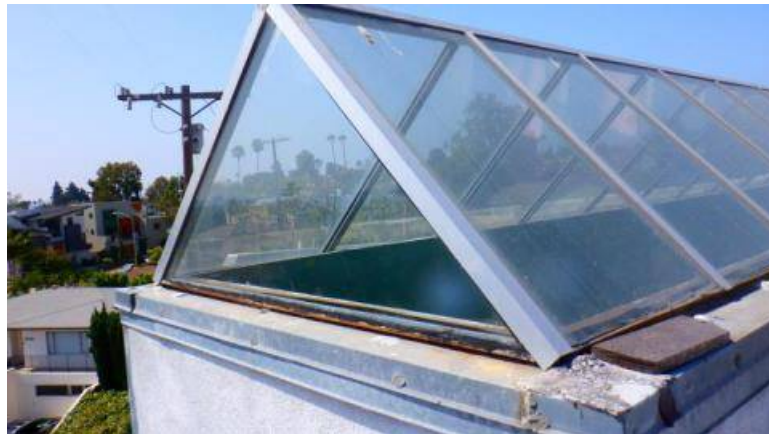
Needs Attention: The mastic is deteriorated and worn on the skylight and needs to be checked out and repaired at this time.

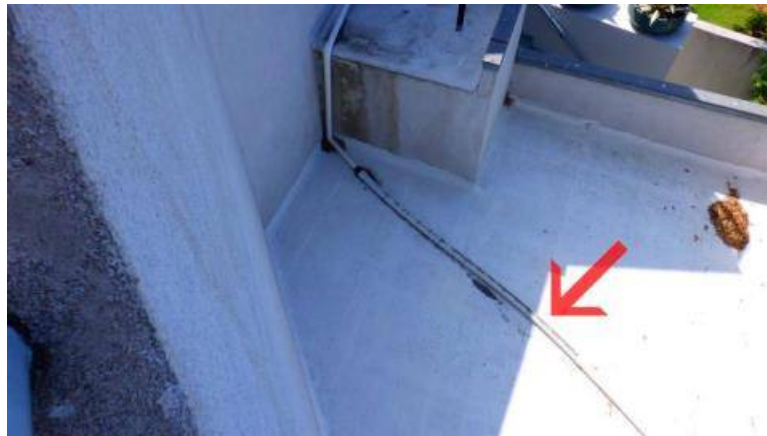
There are items installed on the roof that are not properly raised above the roof surface and inhibit the flow of water off the roof. These should be closely monitored to ensure that they do not block the water and that the roof remains leak free.

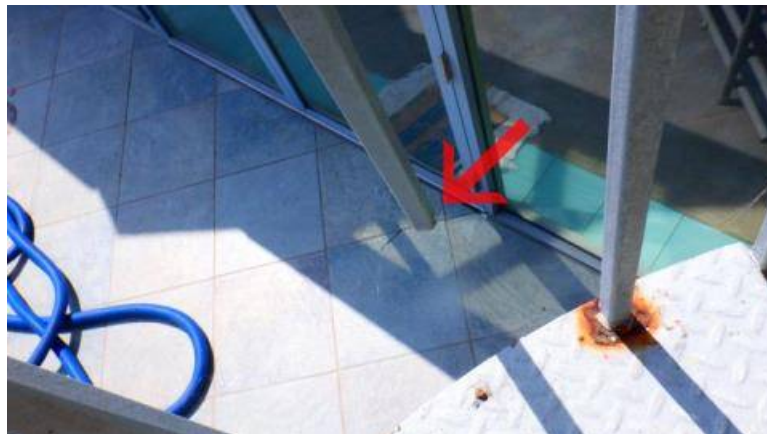
Not Acceptable: The railing does not return to the wall but stops with the end of it exposed. This is considered a safety hazard as the end of it could catch a garment or handbag and cause someone to trip or fall

The rails are not attached in areas, such as at the spiral stairs. This is a safety hazard

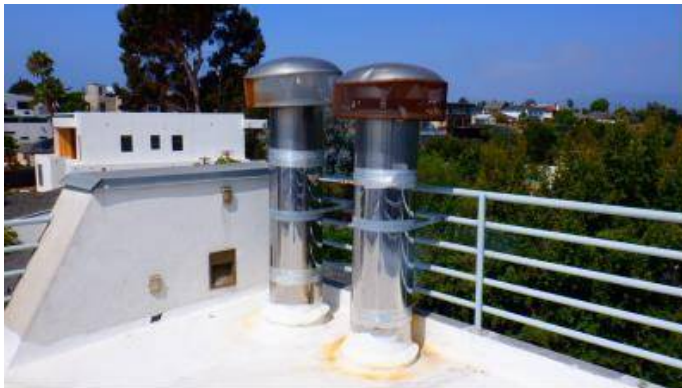
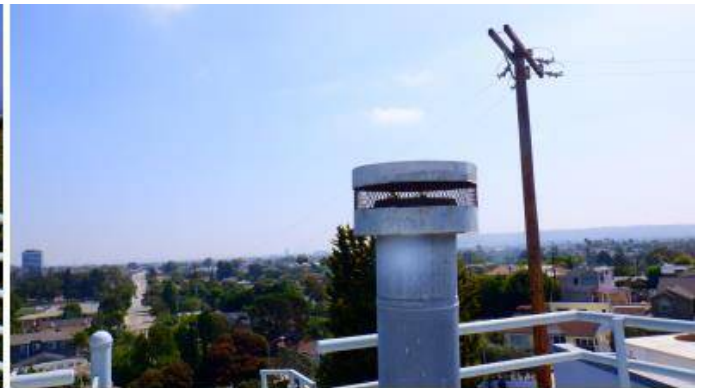
This chimneys are located at the back for the living room, the master and second bedroomss.

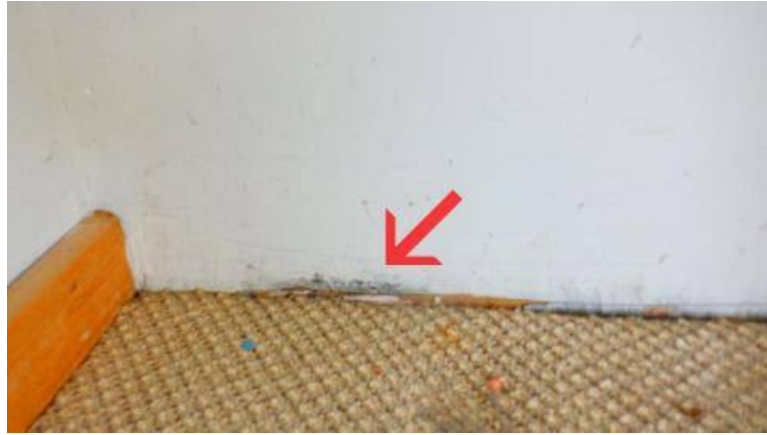
Needs Attention: There are areas that contain mold-like substances, such as at the lower back wall of the closet.

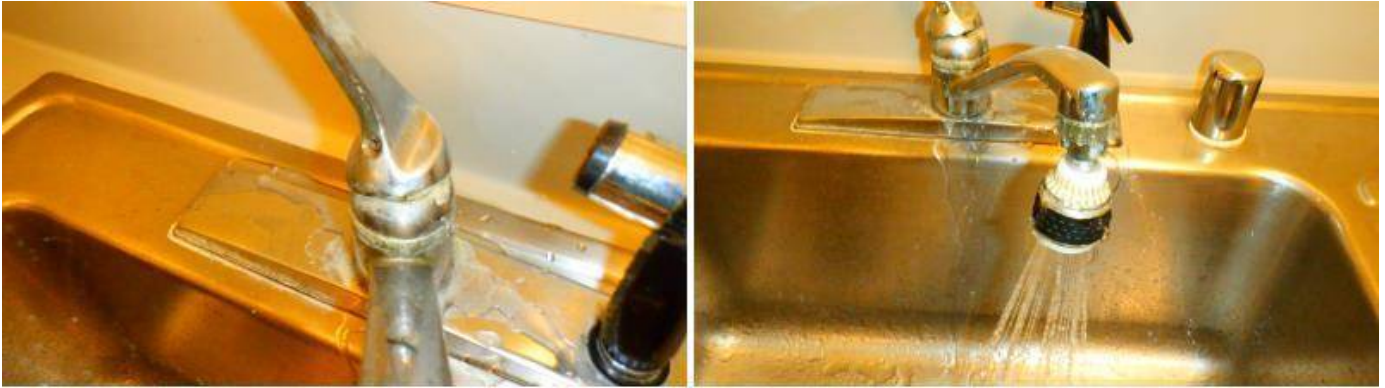
Needs Attention: The faucet is older and leaking in areas, such as at the base and end of the spout.

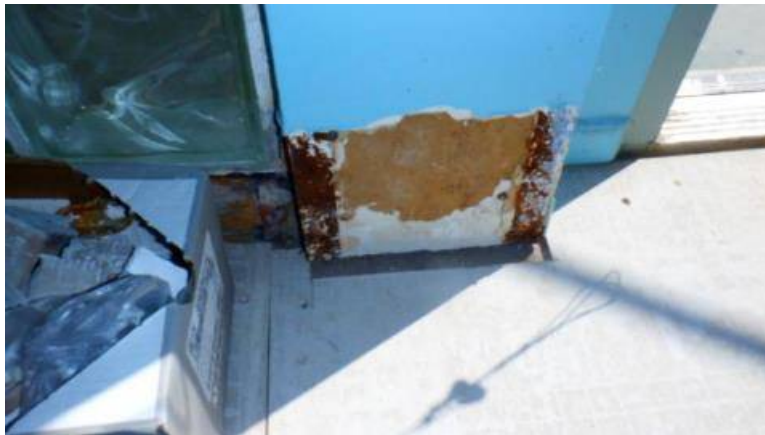
Needs Attention: There are areas of patching and apparent repairs on the wall / ceiling surfaces.

The walls are open with rusty moulding in areas.
