Inspection No. : 202401002
Inspection Date : January 3, 2024
Address : 835 Locust Avenue, Unit #617, Long Beach, CA 90813

Inspector : Ned McTaggart
Client : Guy & Jennifer Moon

This is a condominium, two story structure built on a flat lot. Estimated age is approximately 15 to 20 years old. Weather at the time of inspection was sunny.

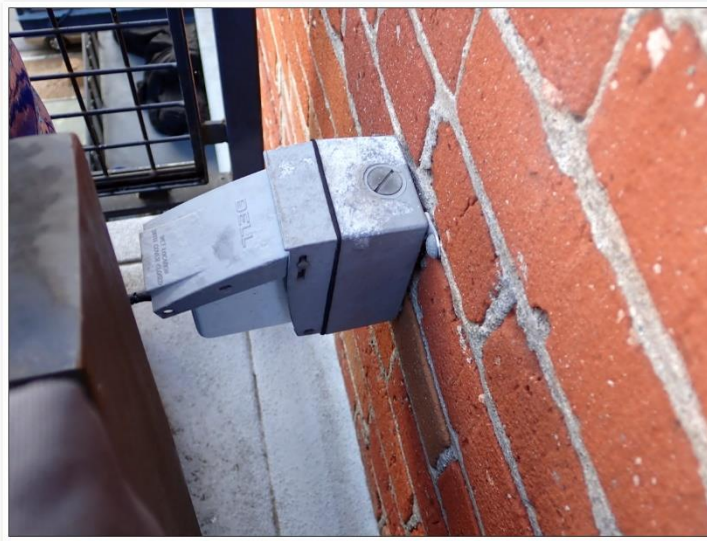
203 Electrical: **Ground fault interrupter provided for safety is inoperable.**

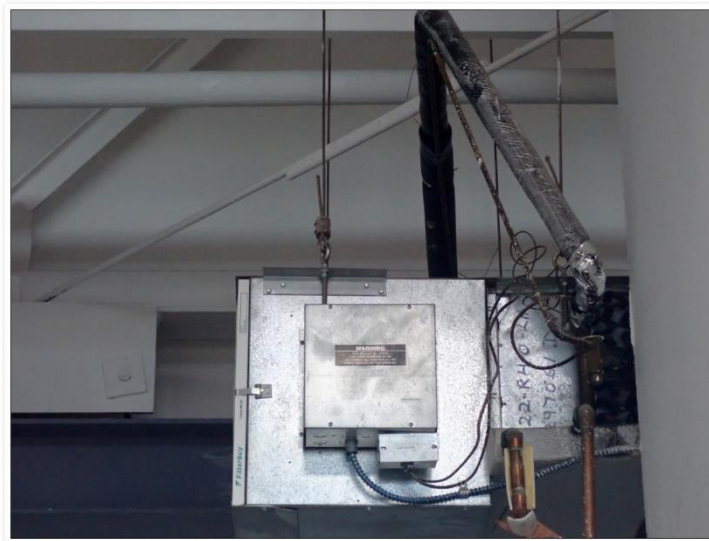
Electric forced air heating unit located above bathroom. Electrical disconnect provided near this unit.

Suggest checking filter prior to closing.

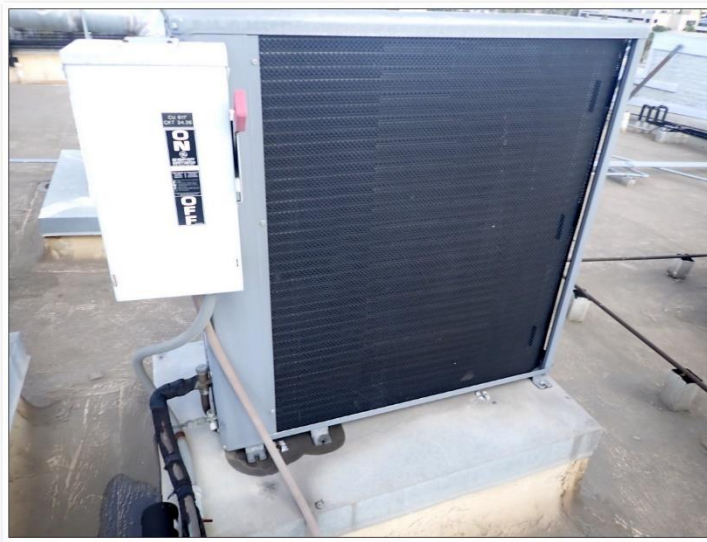
402 Air Conditioning: Electric. Compressor is located on roof.

Coolant line does not appear to get cold and the temperature noted at return is less than desired 18° – 22° differential from register. We suggest an air conditioning specialist make a basic service call to verify system's performance prior to close of escrow.

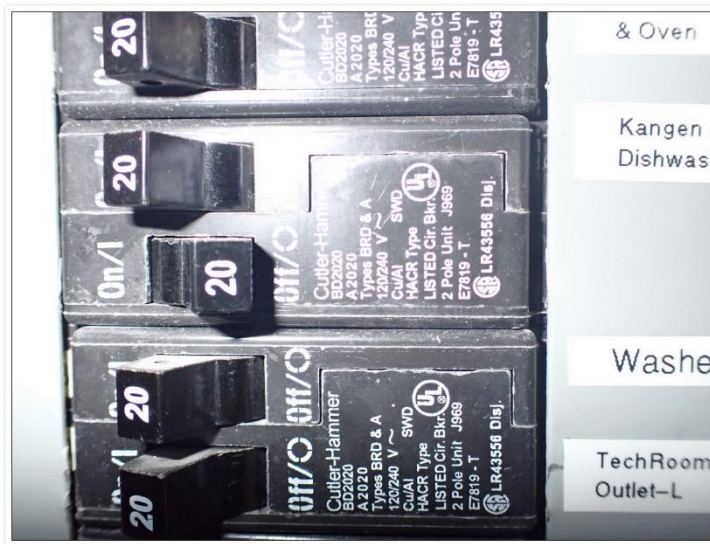
407 Water Heater:	Association maintained; please see number 117.
407a Venting:	Association maintained; please see number 117.
408 Electrical:	The main electrical service is approximately 125 amps. Service entrance is underground with main panel located in electrical room. Overload protection is provided by breakers. Main disconnect noted. Wiring where visible is copper. Copper is preferred for durability and low maintenance. Sub panels located at air conditioning unit and in living room.

One 20-amp breaker which is not labeled noted is in off position; unable to determine reason; suggest consulting with specialist for further review prior to close of escrow.

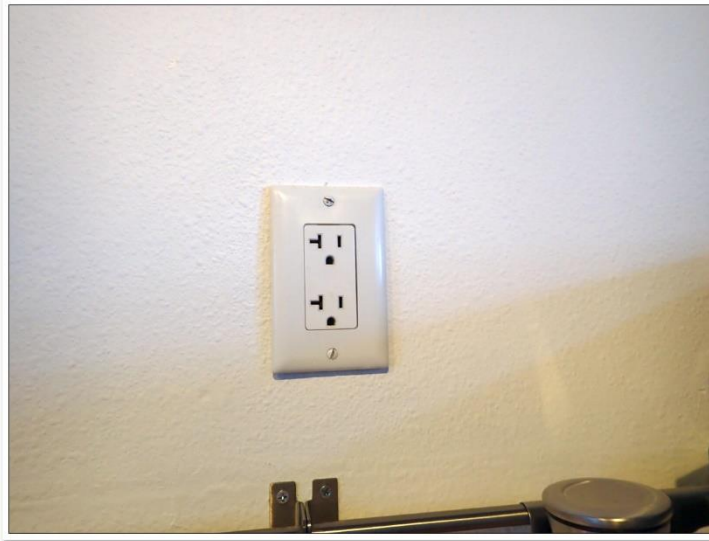
There is no ground fault interrupter noted at upper rear left outlet which may not have been standard at the time of construction. However, today's standards require ground fault interrupters at all areas within five feet of running water and external outlets. We suggest installing a ground fault interrupter in this area as a safety upgrade.

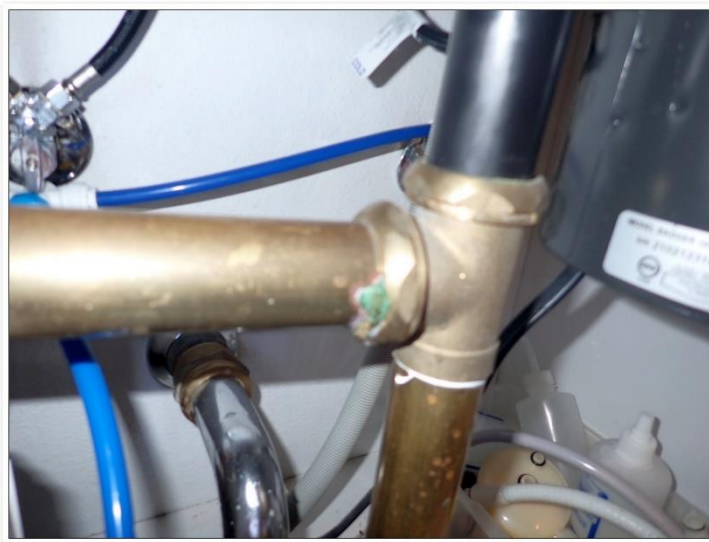
511 Traps/Drains/Supplies: **Leak noted under sink at drain; we advise making necessary corrections.**

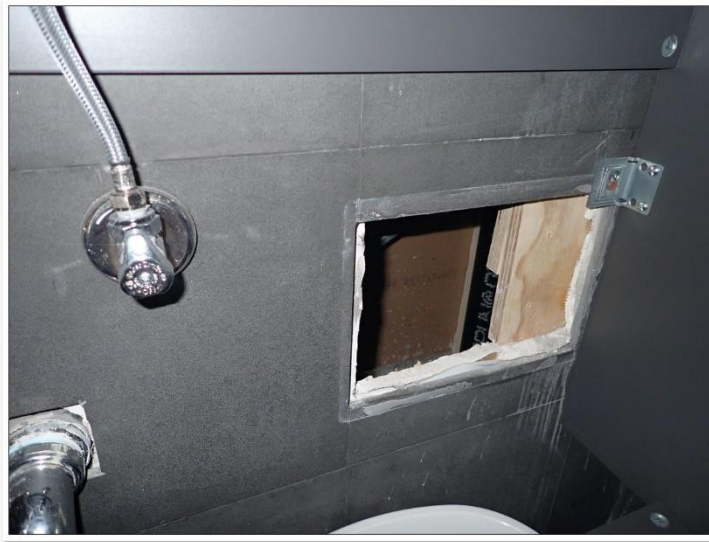
722 Walls: **Missing wall covering noted under sink; we advise making necessary corrections.**
