Sewer Line Report

May 13, 2024

**6319 Cedros Ave & 14700 Friar Street
Van Nuys, CA 91411**

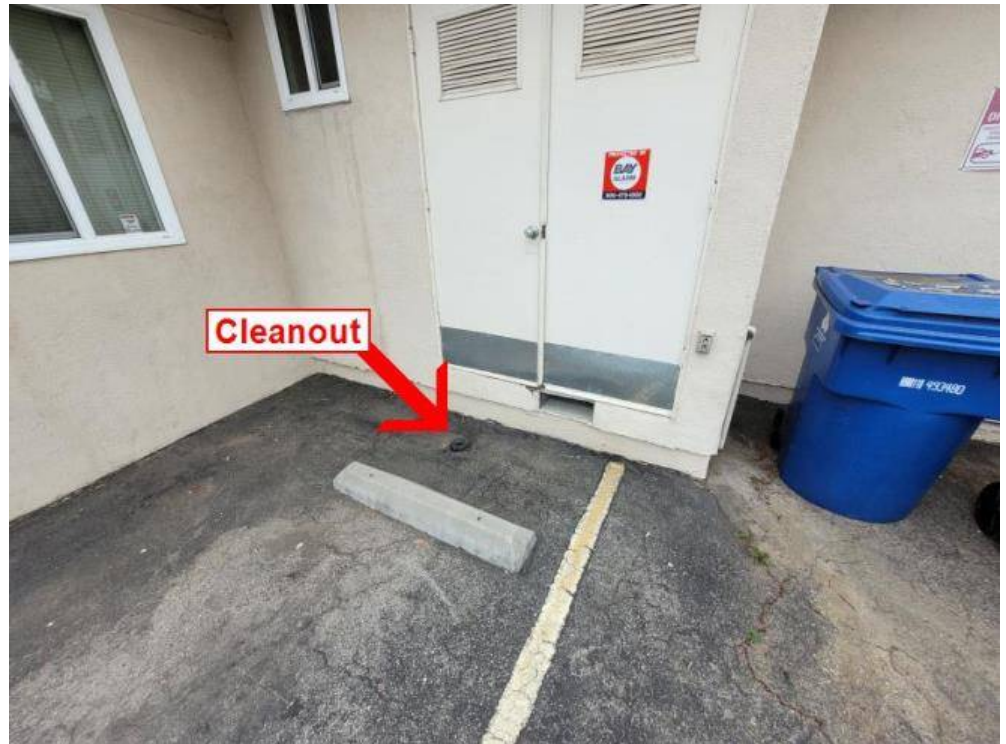
CLEANOUT LOCATION:

The Cleanout accessed was located in the front parking area near the water heater closet.

Access to the line was through a 4" inch cleanout.

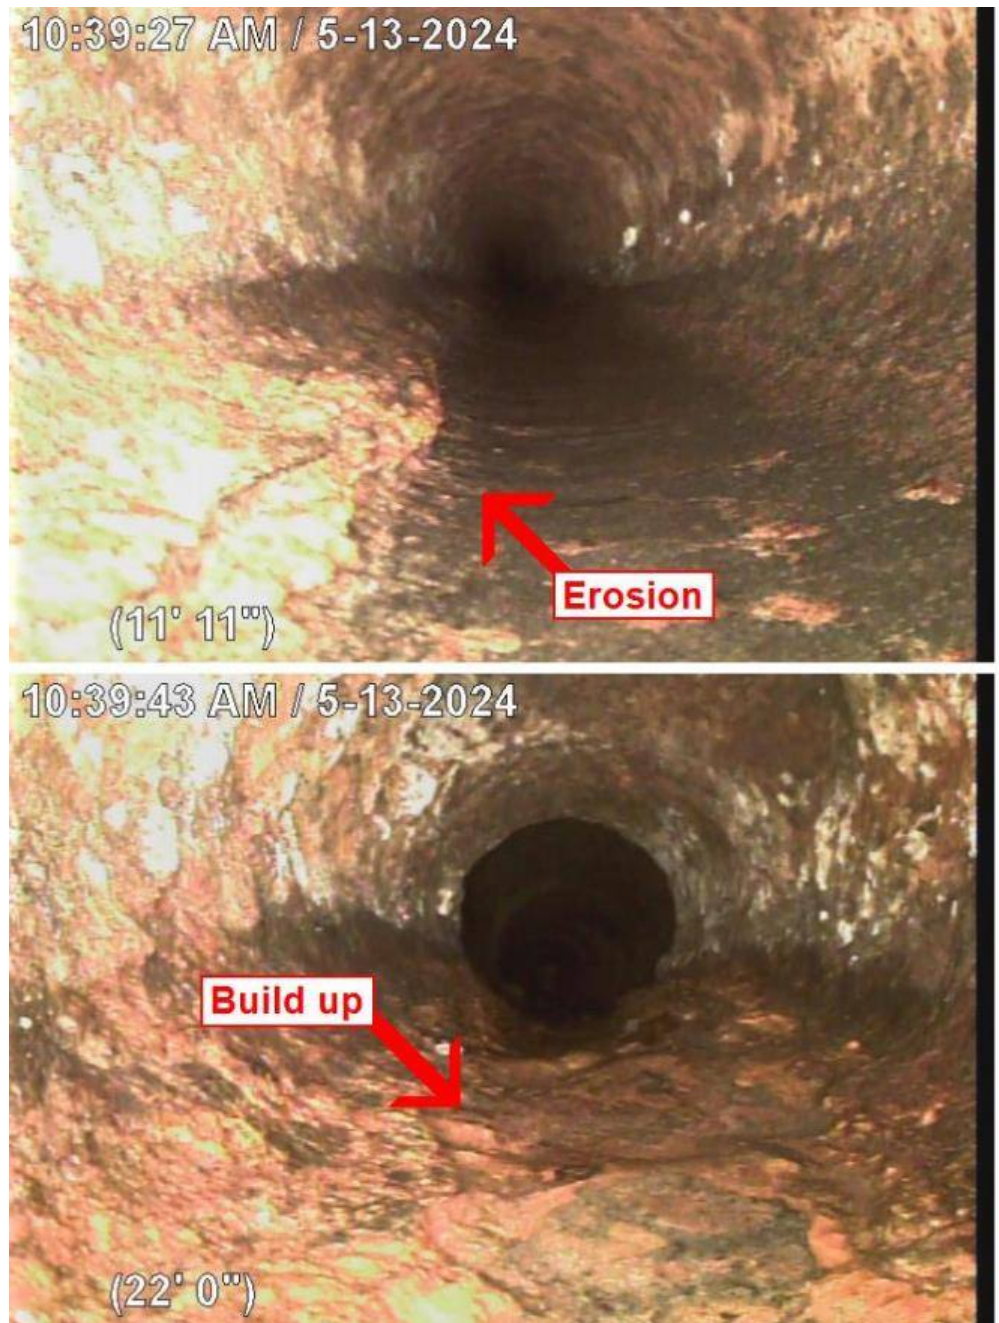
Needs Attention:

The sewer line was composed of much older Cast Iron with signs of deterioration. This approximate 22 feet of four in line needs to be updated via Fiberglass liner.

It is recommended the first approximate 35 feet of Cast Iron and Clay sewer line be replaced via Fiberglass liner options to avoid needing to excavate the entire portion of line.

To Fiberglass spray line the Cast Iron **\$5,000 - \$6,000.**

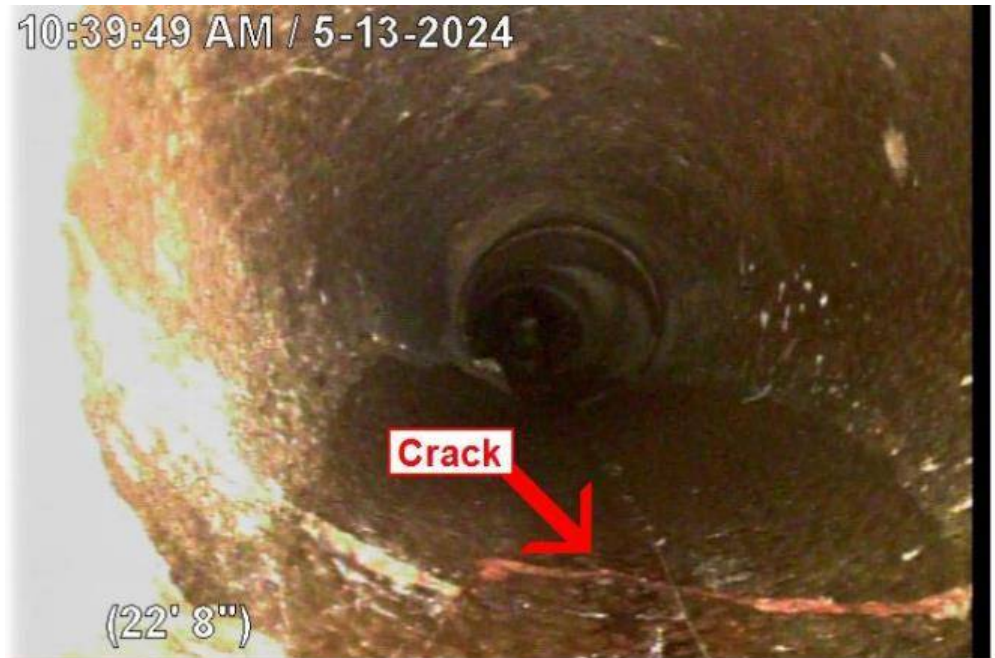
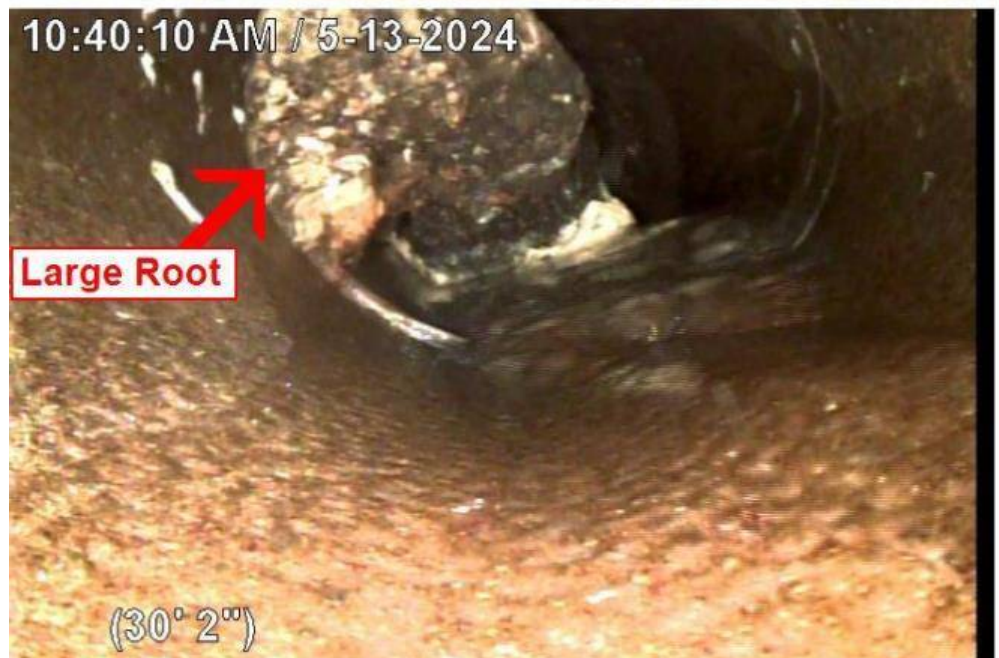
Needs Attention:

In the 6 inch Clay pipe the first approximate 13 feet of which had damage and roots intrusions needs to be addressed.

To Fiberglass line the 6" Clay pipe **\$4,000 - \$5,000.**

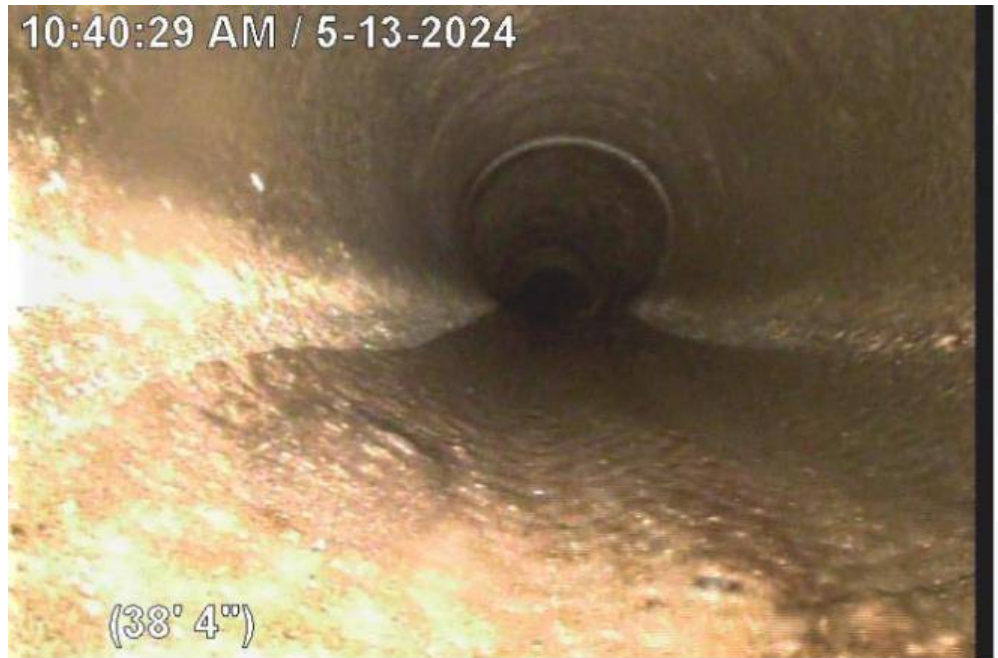
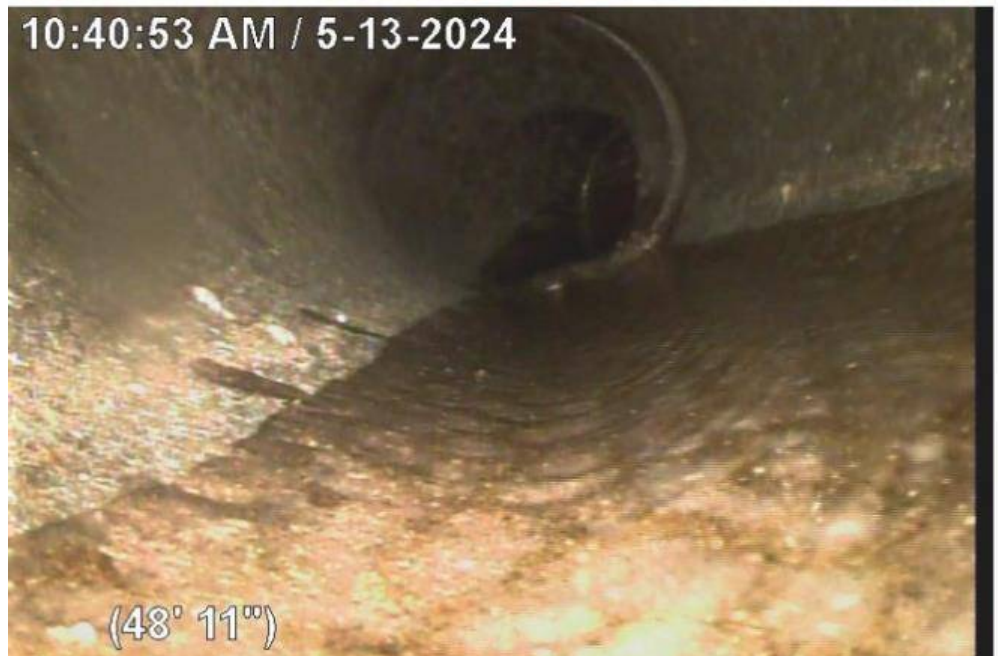
Examples of the serviceable portions of the Clay pipe beyond the damaged sections.

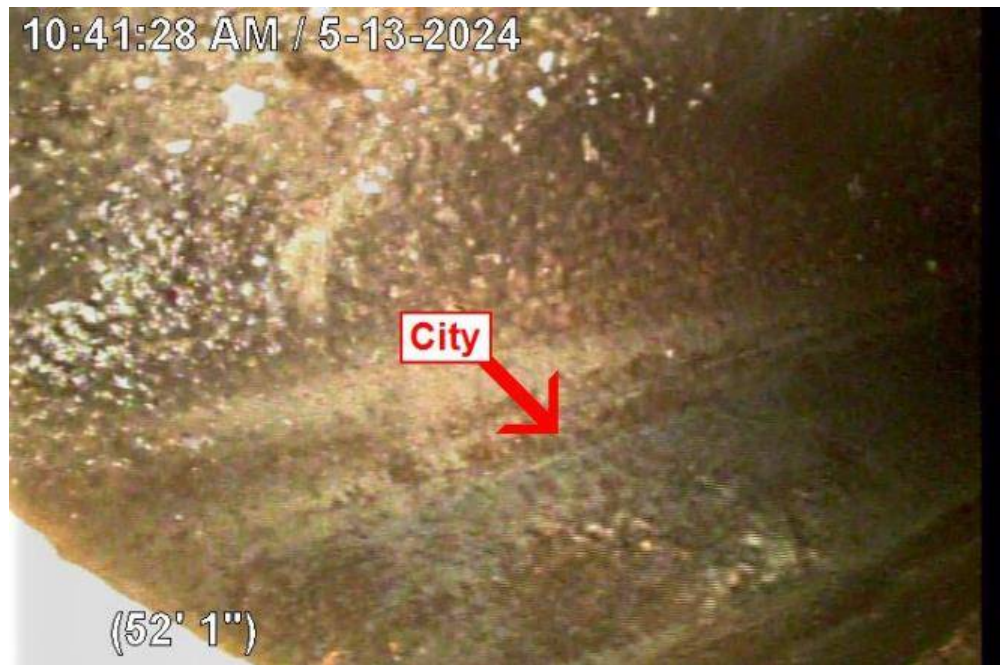
CITY CONNECTION
CONDITION:

The City Main connection was located at approximately 52 feet from the Cleanout.
